TOWN OF MIDDLEBURY

REGULAR MEETING MINUTES Tuesday, February 28, 2023 7:30 P.M.

SITE/LOCATION: Proposed Southford Park 555 Christian Road & 764 Southford Road Middlebury, Connecticut	REMA JOB NO.: 23-2579-MDL28	ANNOTATED PHOTO LOG
	INVESTIGATOR(S): George T. Logan, MS, PWS, CSE		
DATE: February 18, 2023	FACING: SOUTHWESTERLY	PHOTO NO.: 5

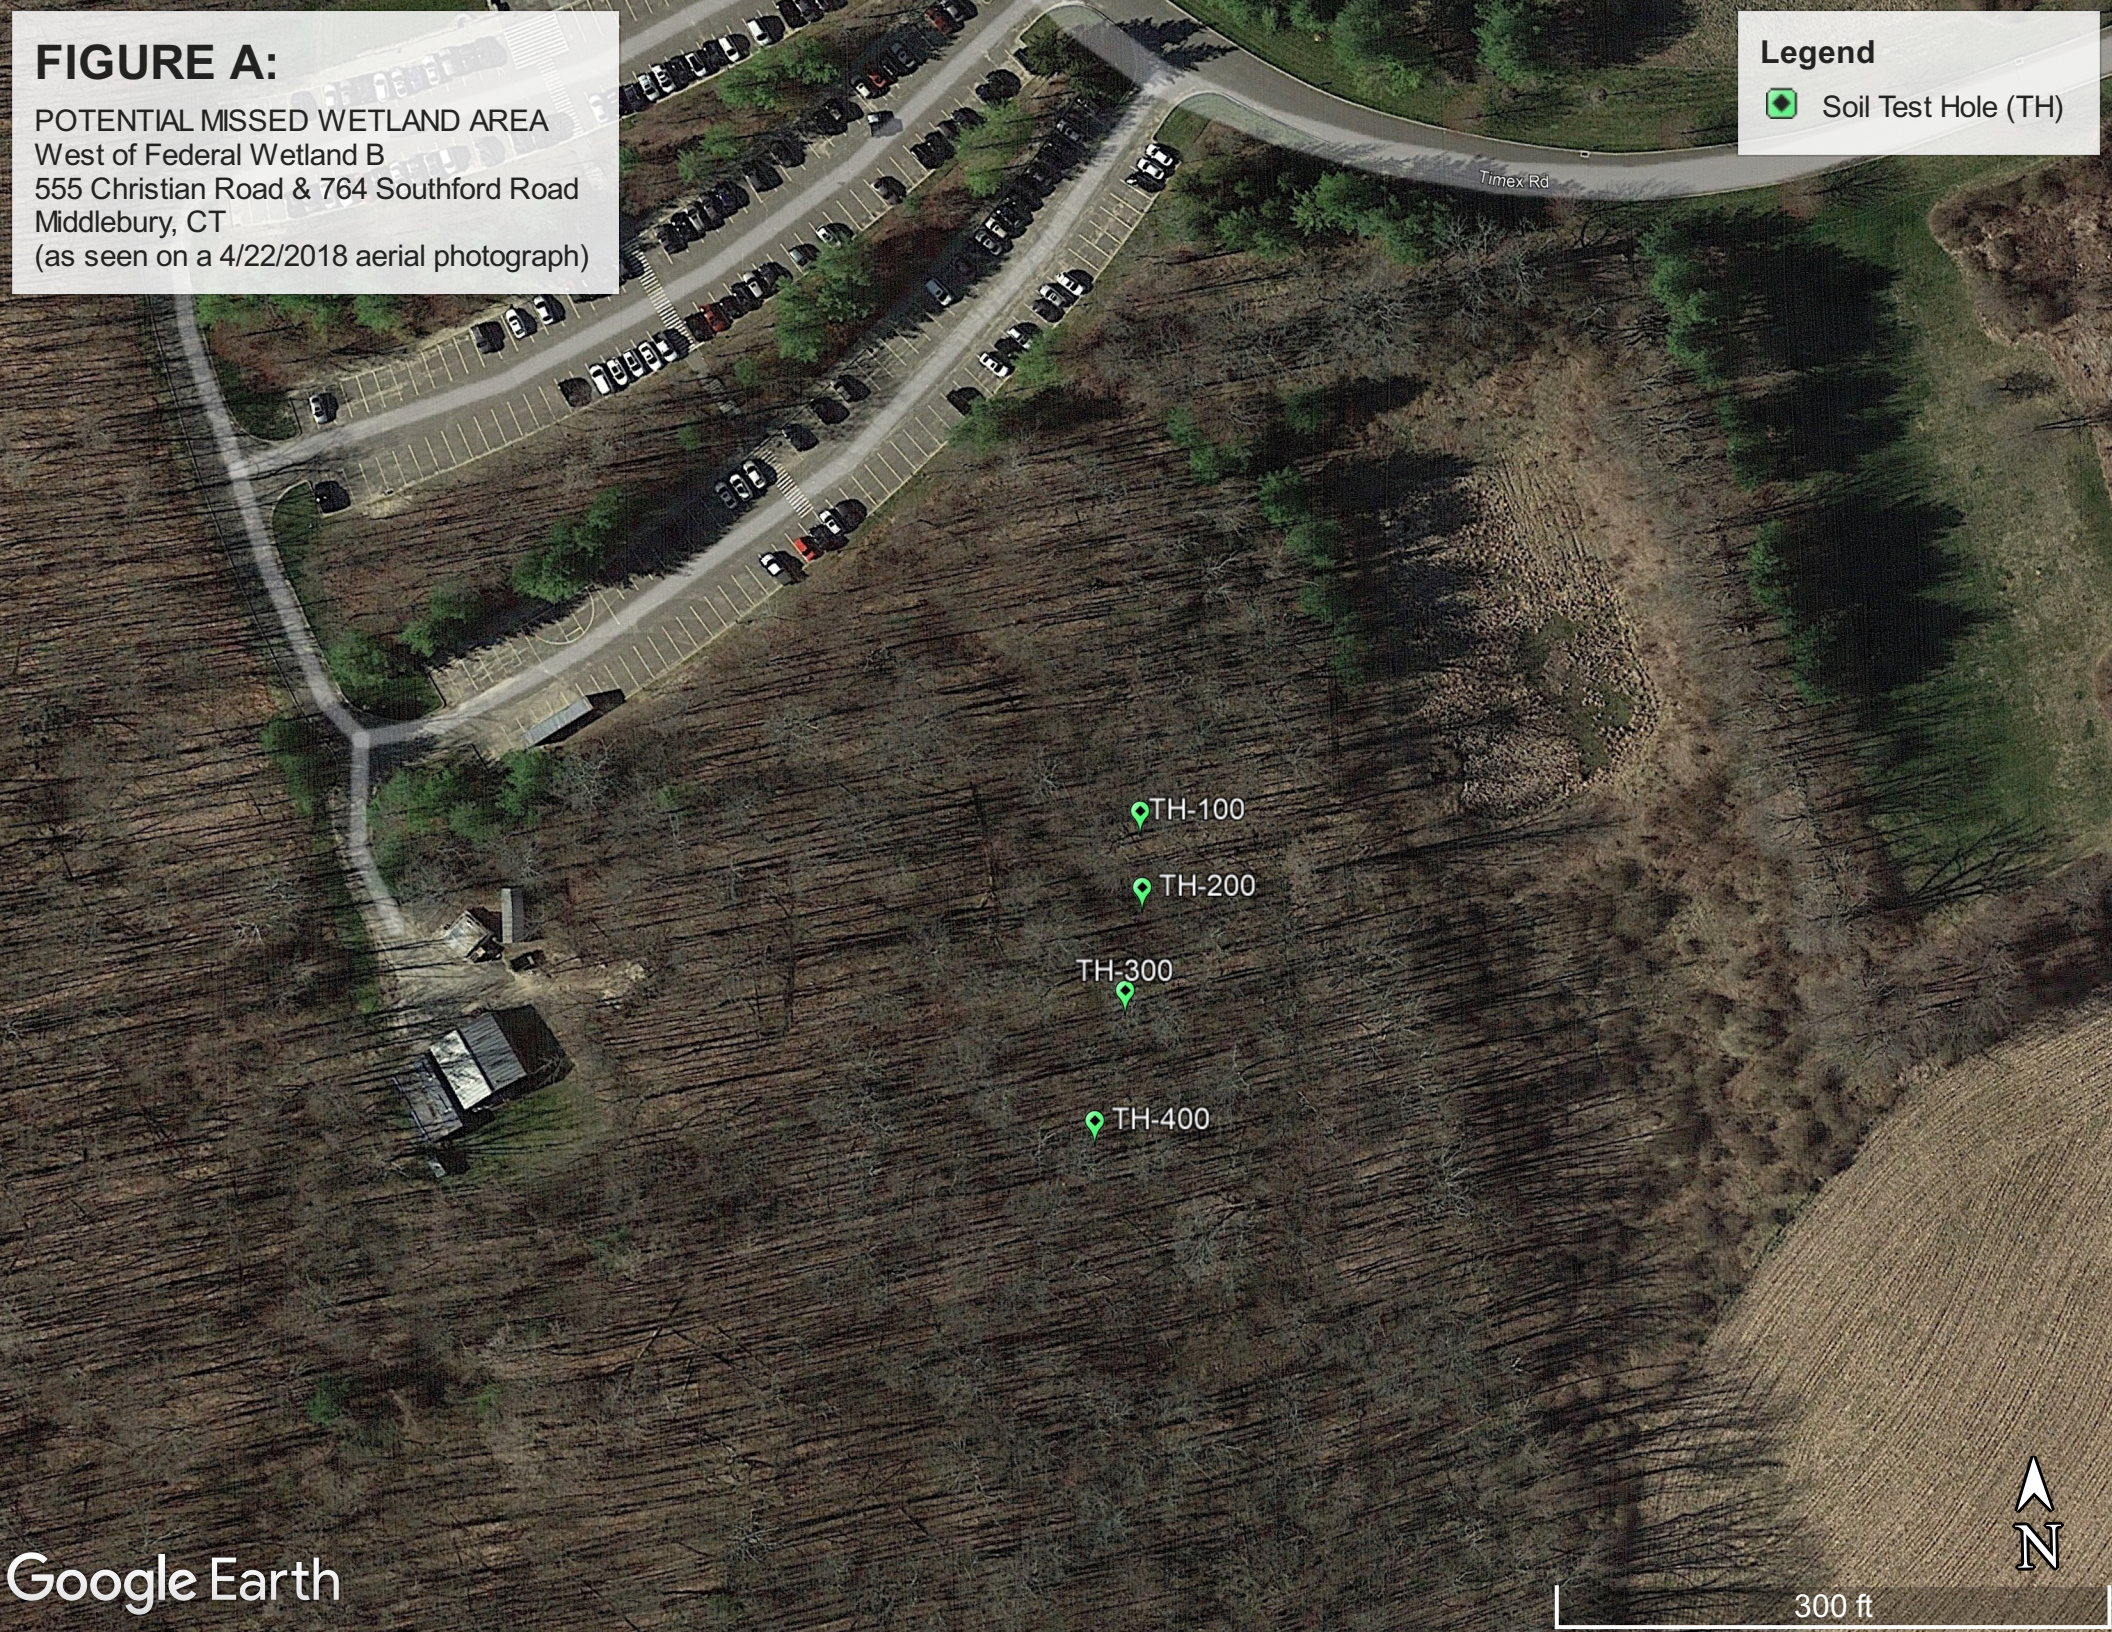
FIGURE 2: AREA B

On February 18, 2023, REMA also re-visited one of the areas (i.e., Area B) depicted in Figure 2, that had been forwarded to SLR on February 4, 2018. As had been mentioned in our communication at that time, poorly drained profiles had been observed during the February 3, 2023, site visit. REMA developed and logged four additional test holes (i.e., Test Holes 100, 200, 300, and 400), within a linear shallow depressional area in the landscape, approximately 60 to 70 feet westerly of the delineated boundary for Federal Wetland B (see Figure A, attached). While these, more or less, equally spaced test holes, are representative, REMA is of the opinion that a wetland area, which may or may not connect to Federal Wetland B, exists at this location (also see attached annotated photo log).

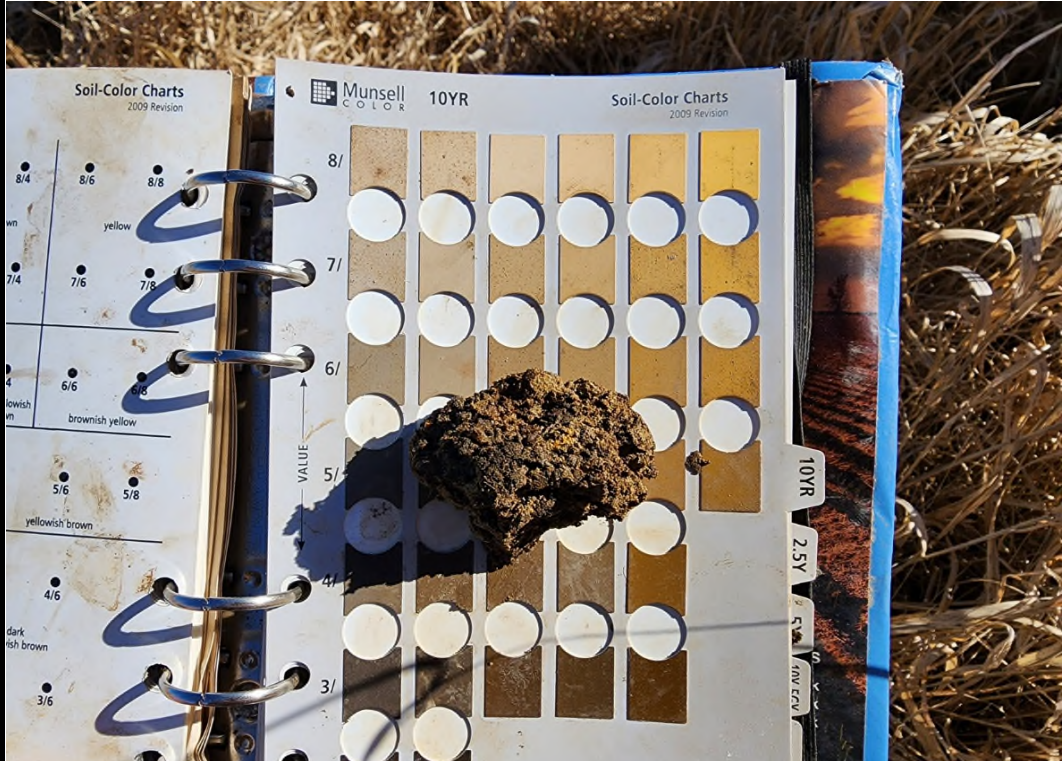
DATE: February 18, 2023	FACING: n/a	PHOTO NO.: 2

TEST HOLE A: Dominant Matrix color within B horizon to a depth of 20 inches from surface is 10YR 6/3, with a few 10YR 6/2 inclusion; somewhat poorly drained; not a regulated wetland

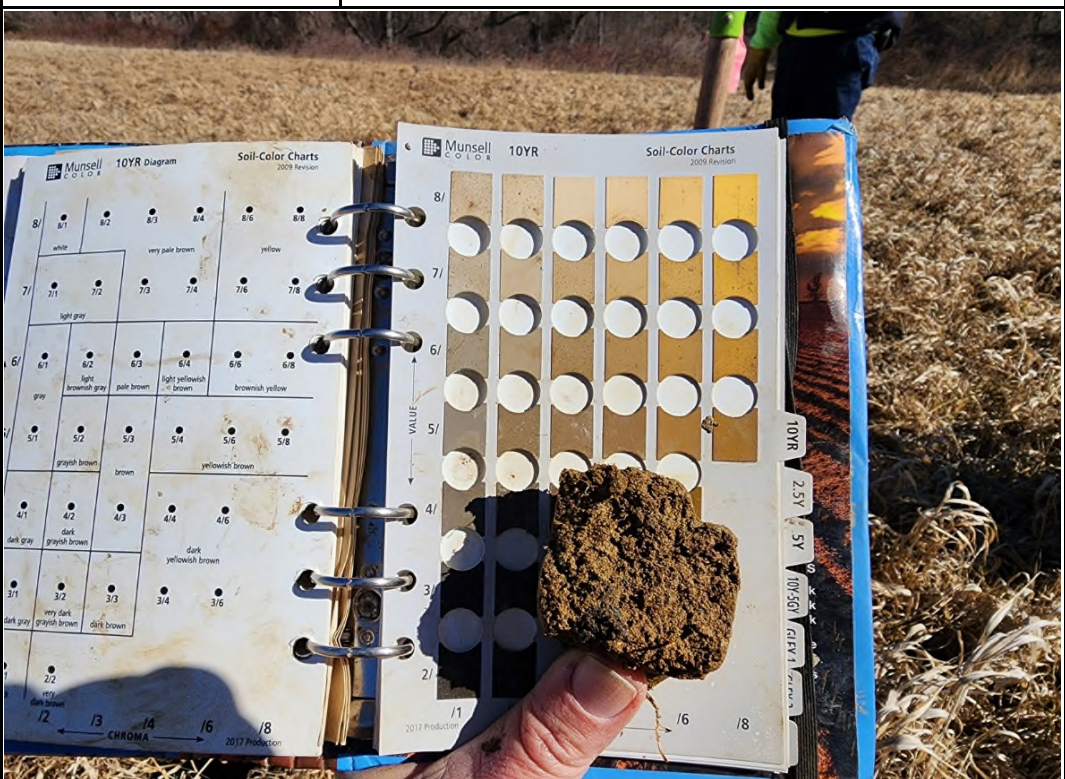
DATE: February 18, 2023	FACING: n/a	PHOTO NO.: 4

TEST PIT B: Dominant Matrix color within B horizon to a depth of 20 inches from surface is 10YR 5/3 and 10YR 5/4; somewhat poorly drained to moderately well drained; not a regulated wetland

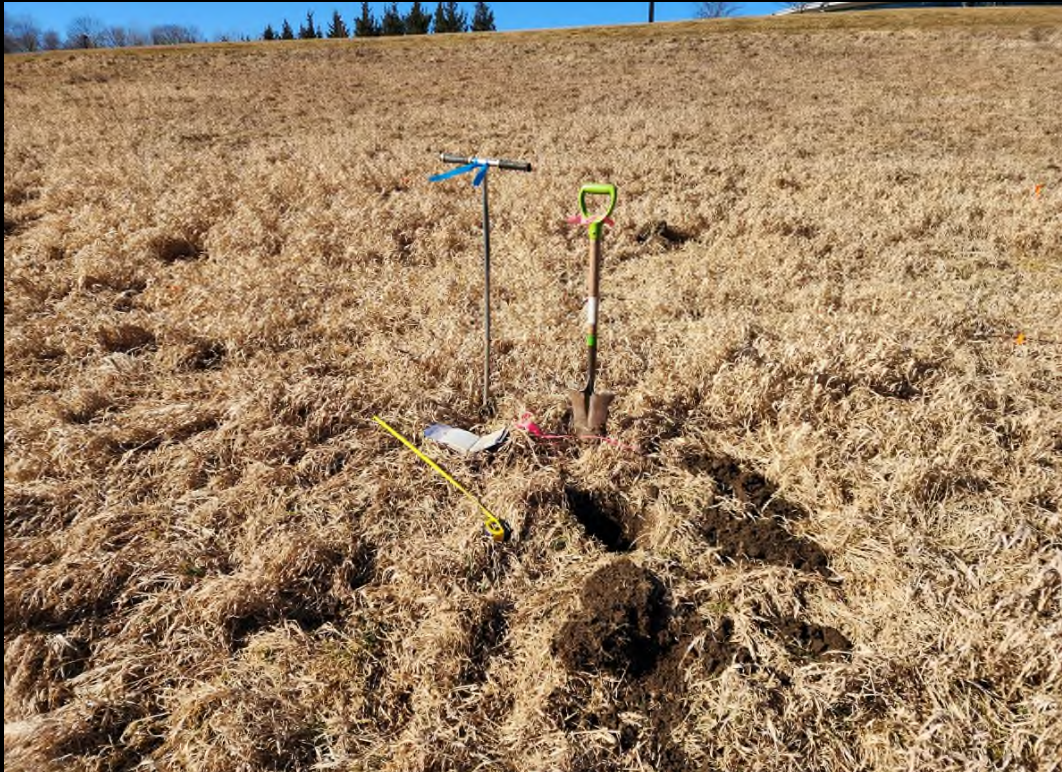
TEST PIT C; located approximately 10 feet easterly (downgradient) of SLR delineated wetland pocket (WM-1 to WM-4)

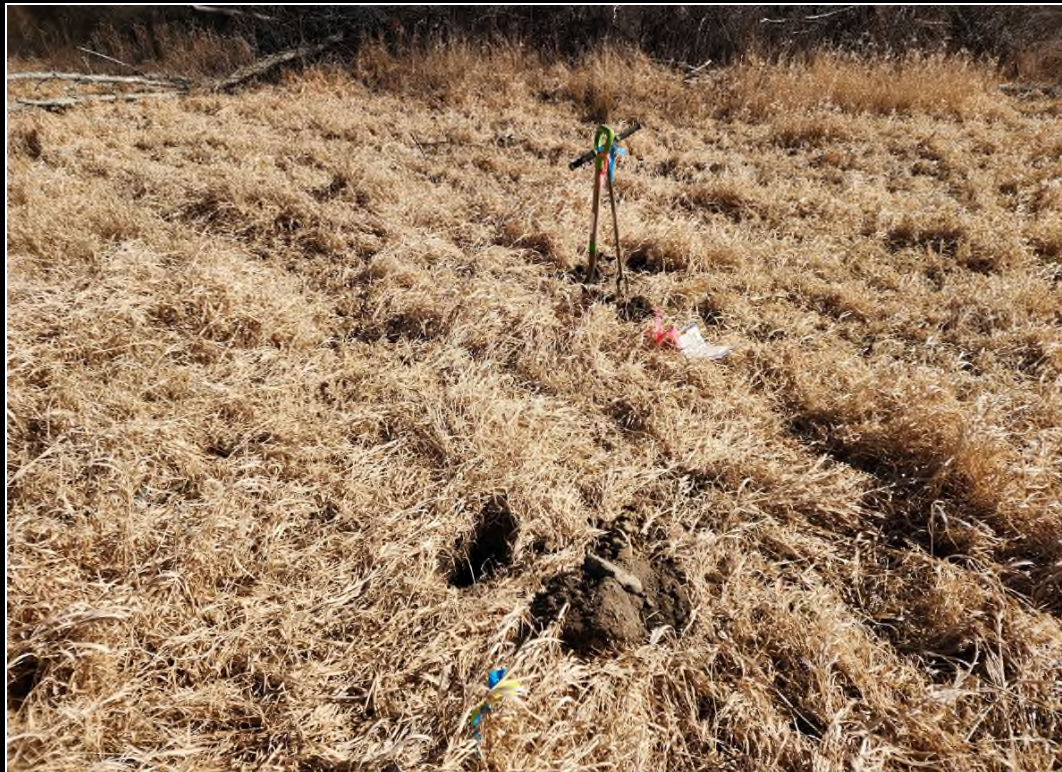
SITE/LOCATION: Proposed Southford Park 555 Christian Road & 764 Southford Road Middlebury, Connecticut	REMA JOB NO.: 23-2579-MDL28	ANNOTATED PHOTO LOG
	INVESTIGATOR(S): George T. Logan, MS, PWS, CSE		
DATE: February 18, 2023	FACING: EASTERLY	PHOTO NO.: 7

TEST PIT D; located at the mid-point between SLR delineated wetland pocket (WF-1 to WF-4), and SLR Test Pit #6

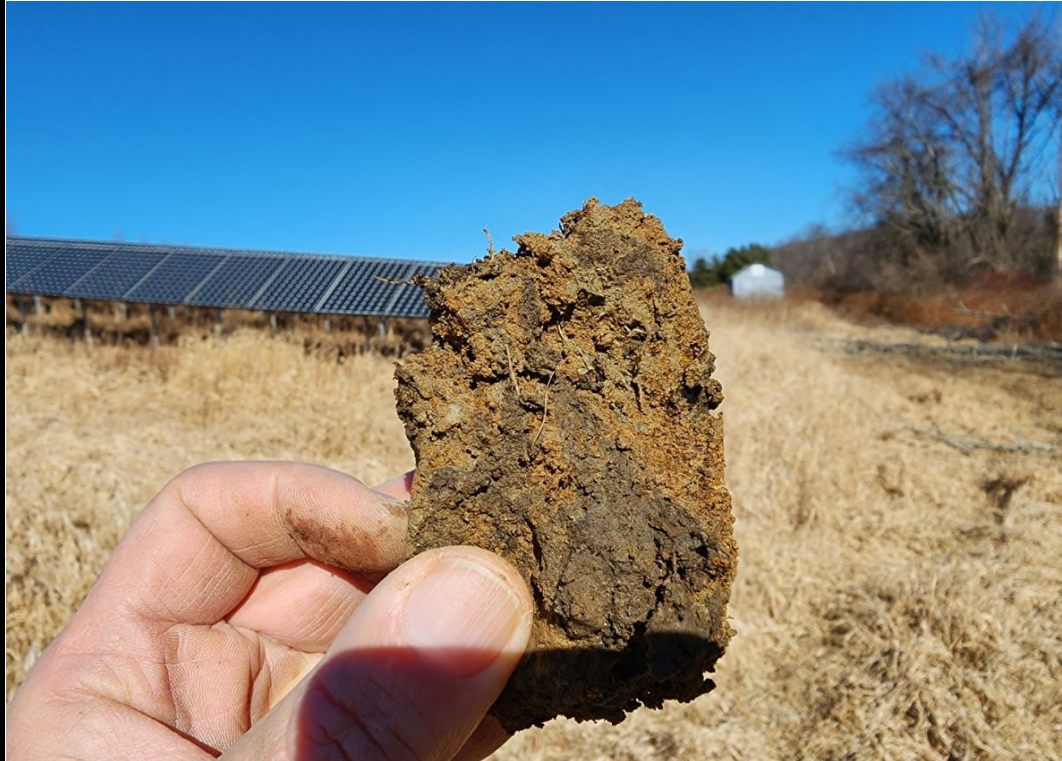
DATE: February 18, 2023	FACING: n/a	PHOTO NO.: 8

TEST PIT D: Dominant Matrix color within B horizon to a depth of 20 inches from surface is 10YR 5/3 and 10YR 5/2, with >10% high chroma mottles (10YR5/6); poorly drained; this is a regulated wetland, which would expand the SLR delineated wetland by no more than 15 feet upgradient (westerly)

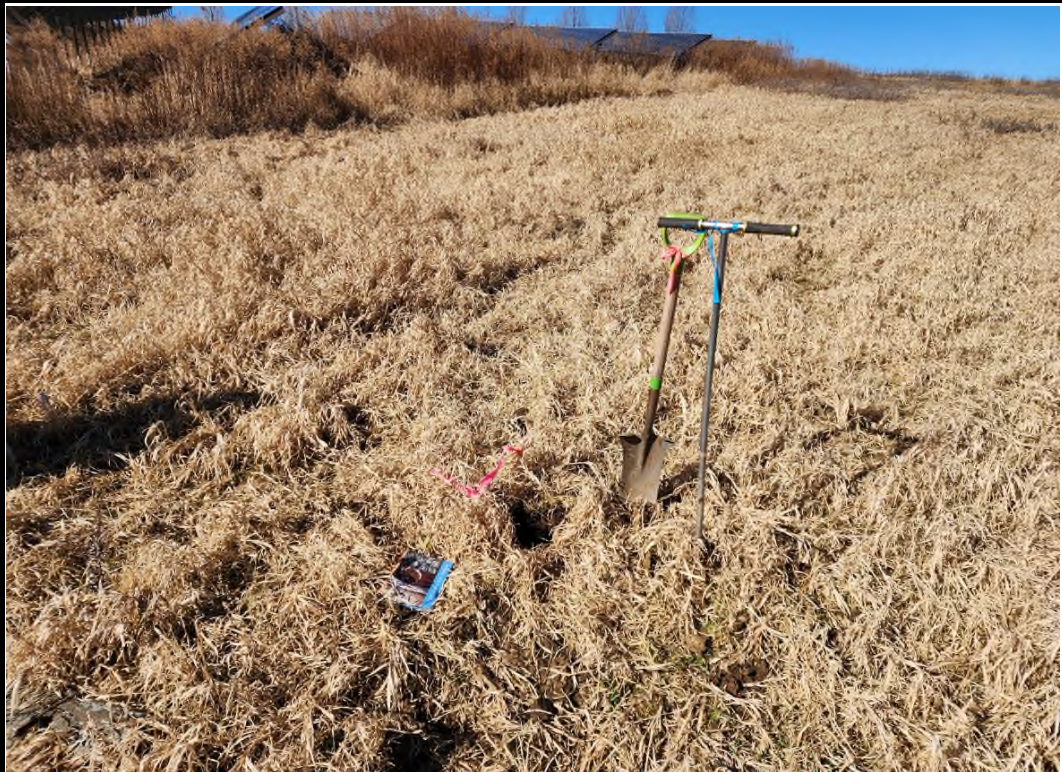
SITE/LOCATION: Proposed Southford Park 555 Christian Road & 764 Southford Road Middlebury, Connecticut	REMA JOB NO.: 23-2579-MDL28	ANNOTATED PHOTO LOG
	INVESTIGATOR(S): George T. Logan, MS, PWS, CSE		
DATE: February 18, 2023	FACING: NORTHWESTERLY	PHOTO NO.: 9

TEST PIT E; located at the mid-point between SLR Test Pit #8 (a wetland test pit) and SLR Test Pit #9 (and upland test pit)

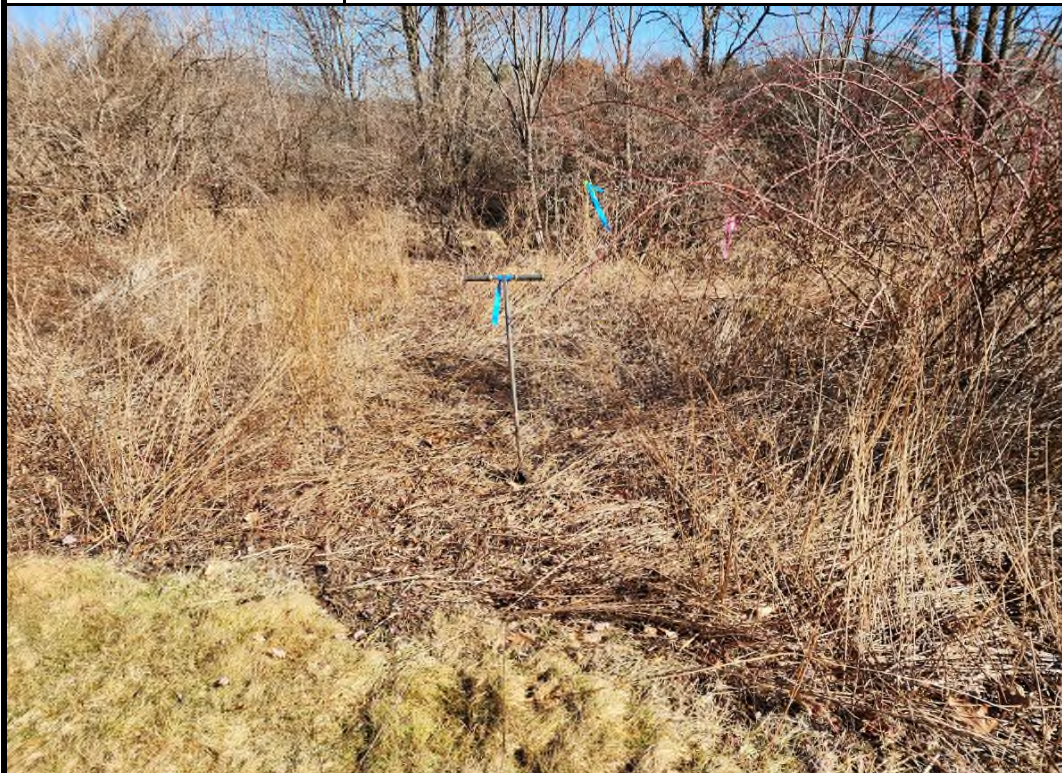
SITE/LOCATION: Proposed Southford Park 555 Christian Road & 764 Southford Road Middlebury, Connecticut	REMA JOB NO.: 23-2579-MDL28	ANNOTATED PHOTO LOG
	INVESTIGATOR(S): George T. Logan, MS, PWS, CSE		
DATE: February 18, 2023	FACING: EASTERLY	PHOTO NO.: 11

<i>SLR wetland delineations of the westerly boundary of Federal Wetland A; generally found accurate. However, this flag (WZ-195) would need to be pulled upgradient by 12 to 15 to take in the poorly drained soils at this location. See gree/blue flag by REMA.</i>

Finally, REMA checked the new SLR delineation along the western side of Federal Wetland A, which would be adjacent to proposed compensatory wetland mitigation area (i.e., flags WZ-193 through WZ-199). While we did not check every single flag, one flag (WZ-195) was found to be roughly 12 to 15 feet downgradient of the actual wetland boundary. We put up an unnumbered green/blue flag to denote the wetland boundary (see Photo 11, attached).

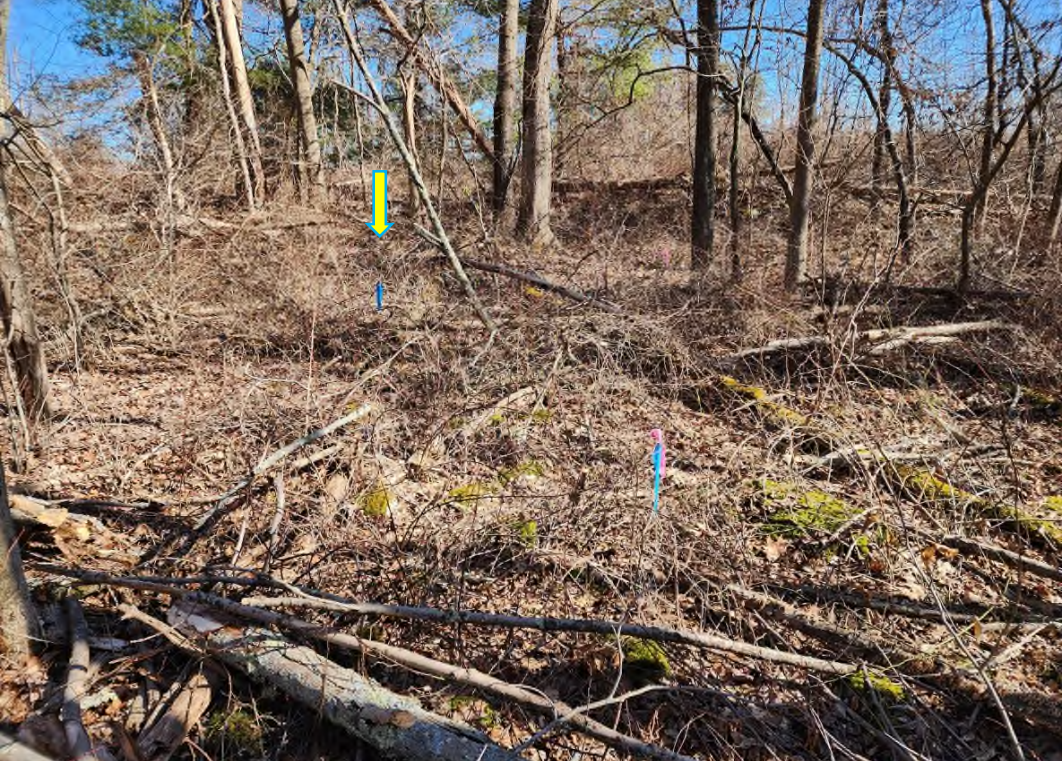
DATE: February 18, 2023	FACING: NORTHEASTERLY	PHOTO NO.: 12

This is the northern tip of Federal Wetland B, where SLR expanded the wetland northerly (upgradient). However, the REMA blue flag (see arrow) would indicate that the wetland tip was somewhat further to the north by a few additional feet.

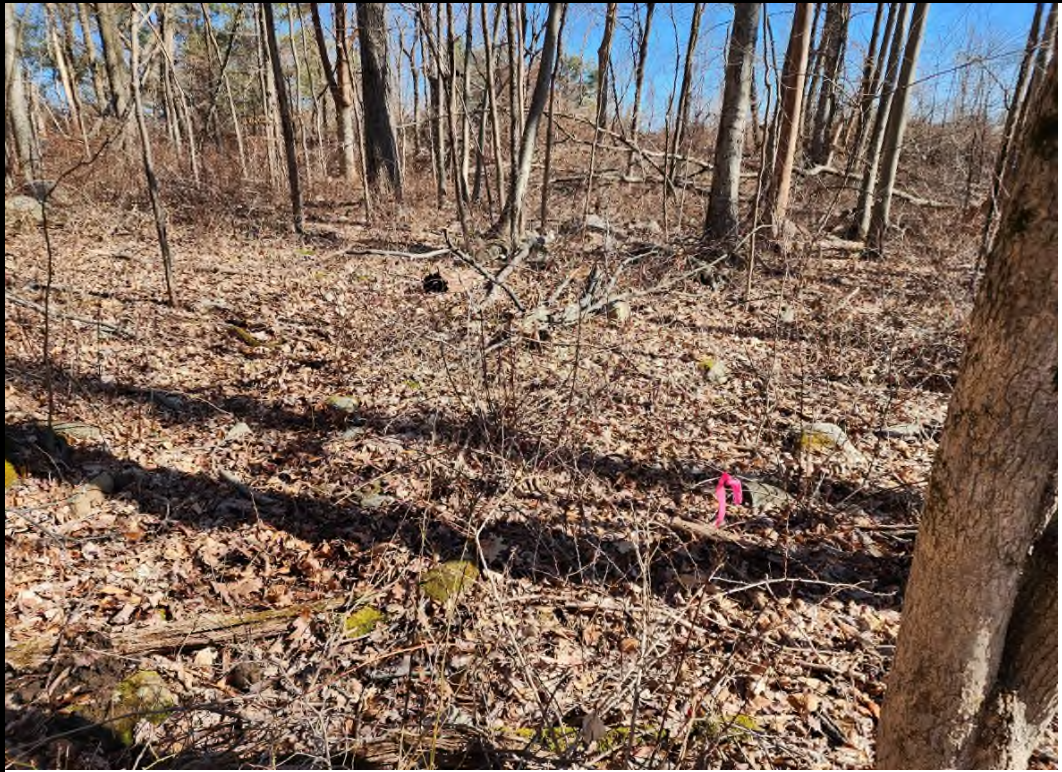
SITE/LOCATION: Proposed Southford Park 555 Christian Road & 764 Southford Road Middlebury, Connecticut	REMA JOB NO.: 23-2579-MDL28	ANNOTATED PHOTO LOG
	INVESTIGATOR(S): George T. Logan, MS, PWS, CSE		
DATE: February 18, 2023	FACING: EASTERLY	PHOTO NO.: 13

<i>TEST HOLE 100; located to the west of Federal Wetland B (see Figure A), in a shallow linear topographical depression</i>

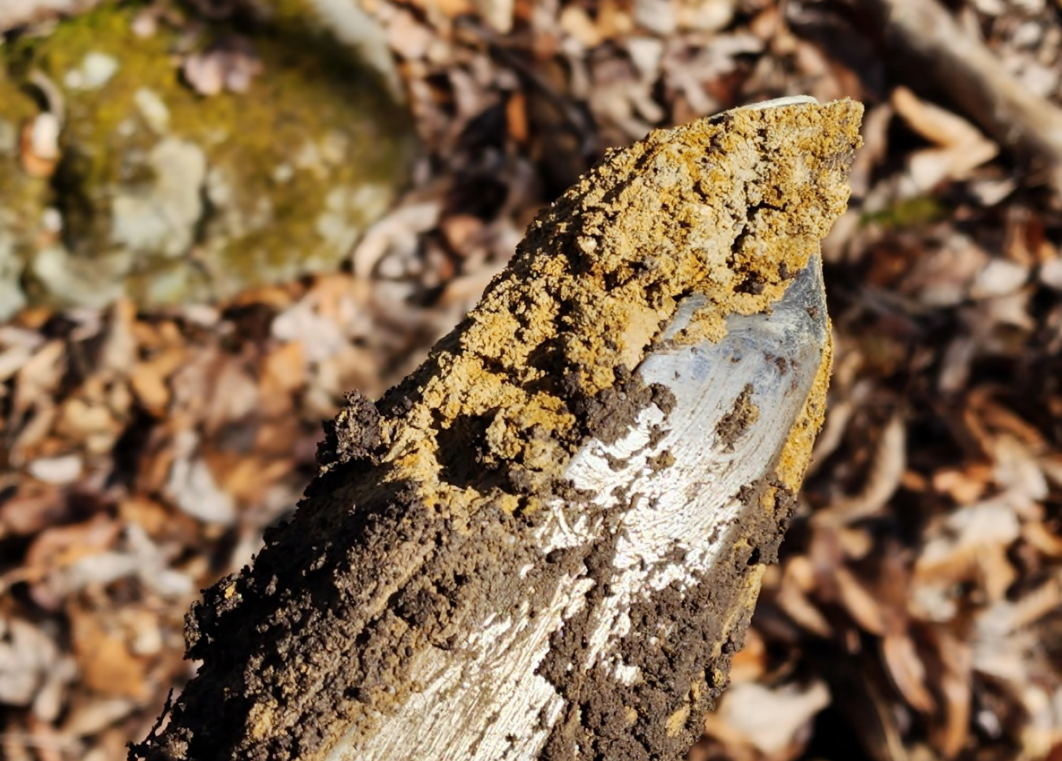
DATE: February 18, 2023	FACING: n/a	PHOTO NO.: 16

<i>The soil matrix color at TH-200 between 17 and 20 is 10YR 5/3 and 5/2, with low chroma mottles (10YR 6/1) and high chroma mottles (10YR 6/6 and 6/8) more than 50% of the pedon; this is a poorly drained profile of a regulated wetland area.</i>

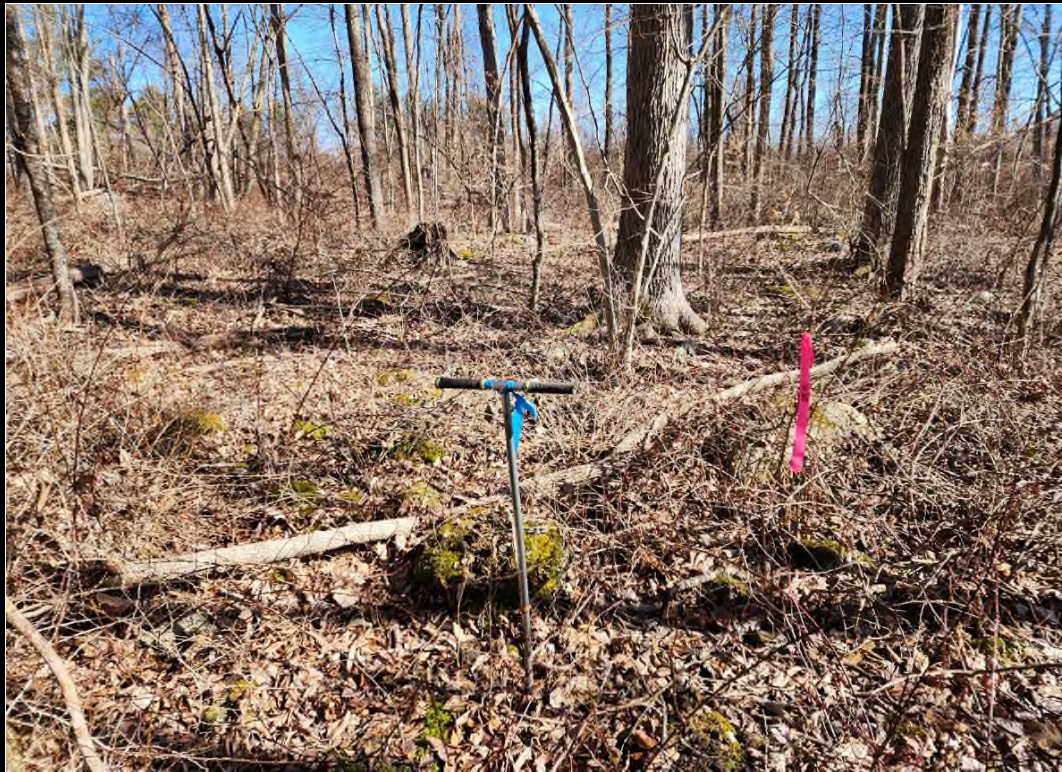
SITE/LOCATION: Proposed Southford Park 555 Christian Road & 764 Southford Road Middlebury, Connecticut	REMA JOB NO.: 23-2579-MDL28	ANNOTATED PHOTO LOG
	INVESTIGATOR(S): George T. Logan, MS, PWS, CSE		
DATE: February 18, 2023	FACING: NORTHEASTERLY	PHOTO NO.: 17

<i>TEST HOLE 300; located to the west of Federal Wetland B (see Figure A), in a shallow linear topographical depression</i>

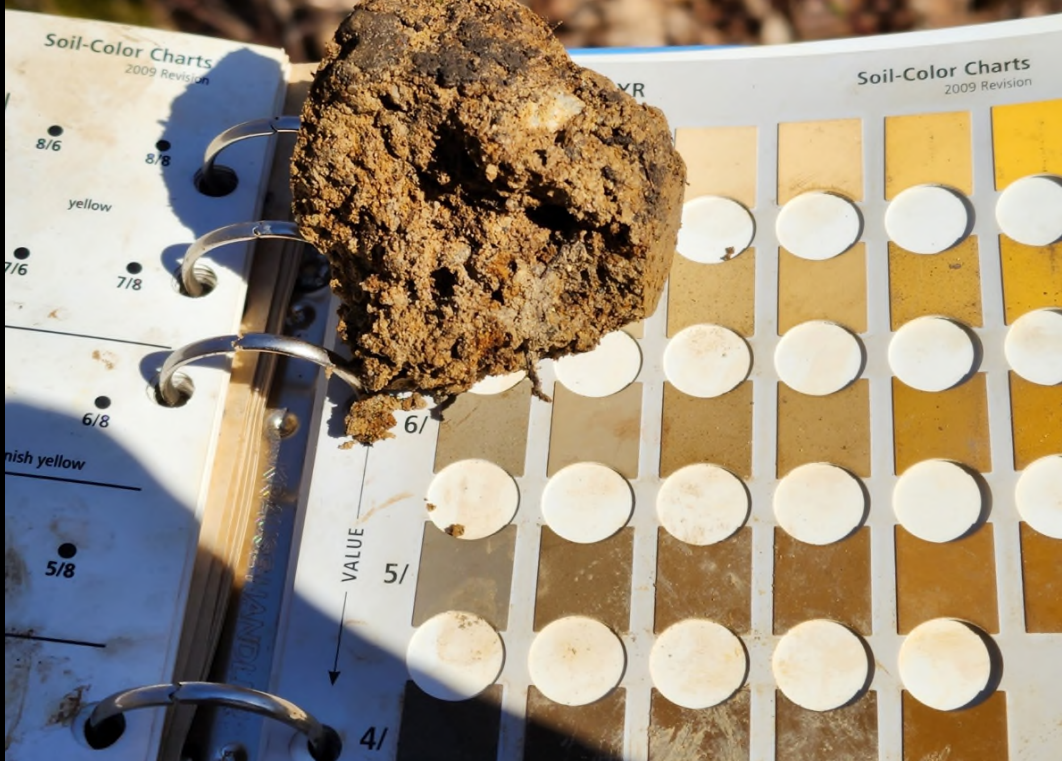
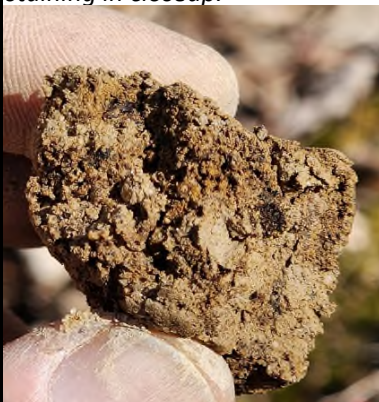
DATE: February 18, 2023	FACING: n/a	PHOTO NO.: 18

<i>The soil matrix color at TH-300 between 16 and 20 is 10YR 5/3 and 5/2, with low chroma mottles (10YR 6/1) and high chroma mottles (10YR 6/6 and 6/8) for more than 50% of the pedon; this is a poorly drained profile of a regulated wetland area. Note also manganese staining in closeup.</i>

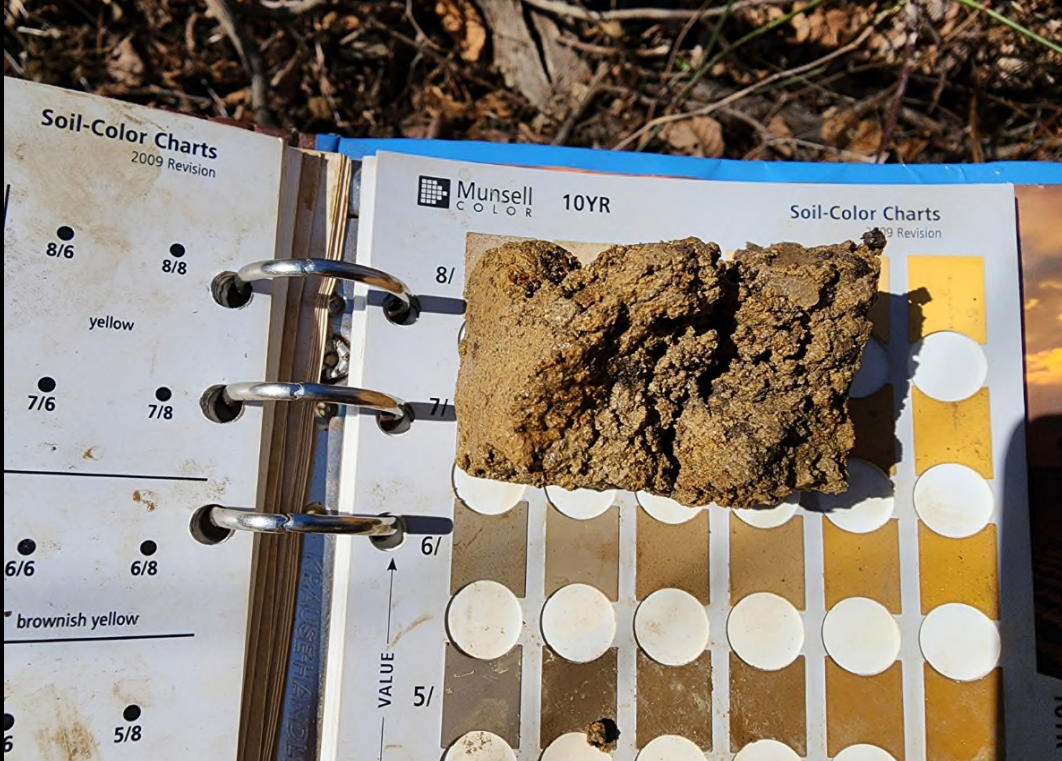
DATE: February 18, 2023	FACING: n/a	PHOTO NO.: 20

<i>The soil matrix color at TH-400 between 16 and 20 is 10YR 6/3 and 6/2, with low chroma mottles (10YR 6/1) and high chroma mottles (10YR 5/6 and 4/6) for about 50% of pedon; this is a poorly drained profile of a regulated wetland area. We note that higher chroma matrix was observed below 20 inches within the firm to very firm till (C-horizon); the diagnostic horizon depth goes to 20 inches; this wetland is perched on the dense till.</i>

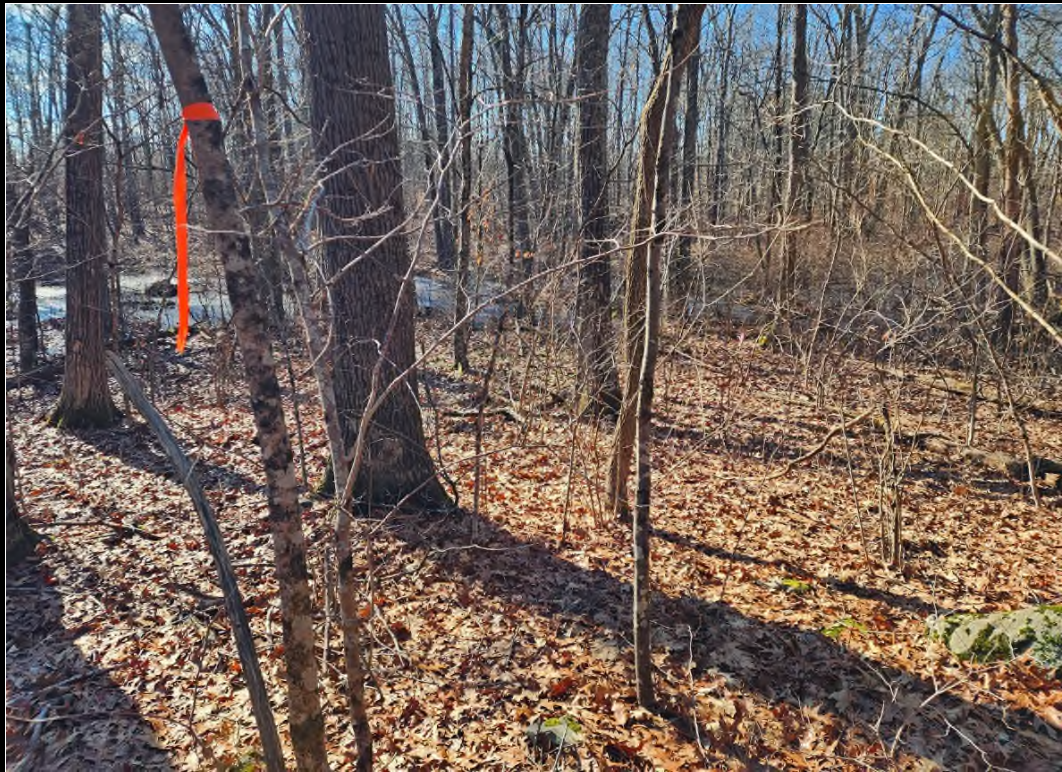
SITE/LOCATION: Proposed Southford Park 555 Christian Road & 764 Southford Road Middlebury, Connecticut	REMA JOB NO.: 23-2579-MDL28	ANNOTATED PHOTO LOG
	INVESTIGATOR(S): George T. Logan, MS, PWS, CSE		
DATE: February 3, 2023	FACING: WESTERLY	PHOTO NO.: 21

<i>Potential Vernal Pool Habitat; just west of westerly property boundary; will be receiving discharge from proposed Detention Basin 110.</i>

At the far southwestern section of the site, the northern portion of Federal Wetland C, which by the way, discharges towards the north, not the south – a topographic saddle exists here – is a headwaters forested wetland, with potential vernal pool habitat characteristics, a subject that we will return to below. The concern here is not necessarily one of potential dewatering, but primarily the need to understand the size of the watershed under existing conditions compared to the watershed under proposed conditions. REMA would ask that the applicant provide this comparison, including graphical representations.

For the balance of the proposed detention basins, including Detention Basins 510, 420, and 320, we would recommend that they all be converted to standard bioretention basins, with underdrains, following the specification promulgated by UNH-SC, including the newest filter media specification, and appropriate pre-treatment, including off-line hydrodynamic separators, as recommended by Trinkaus Engineering, LLC. It is REMA's professional opinion, that should the aforementioned recommendations be implemented, water quality impacts to all of the receiving waters associated with the subject site will be minimized.

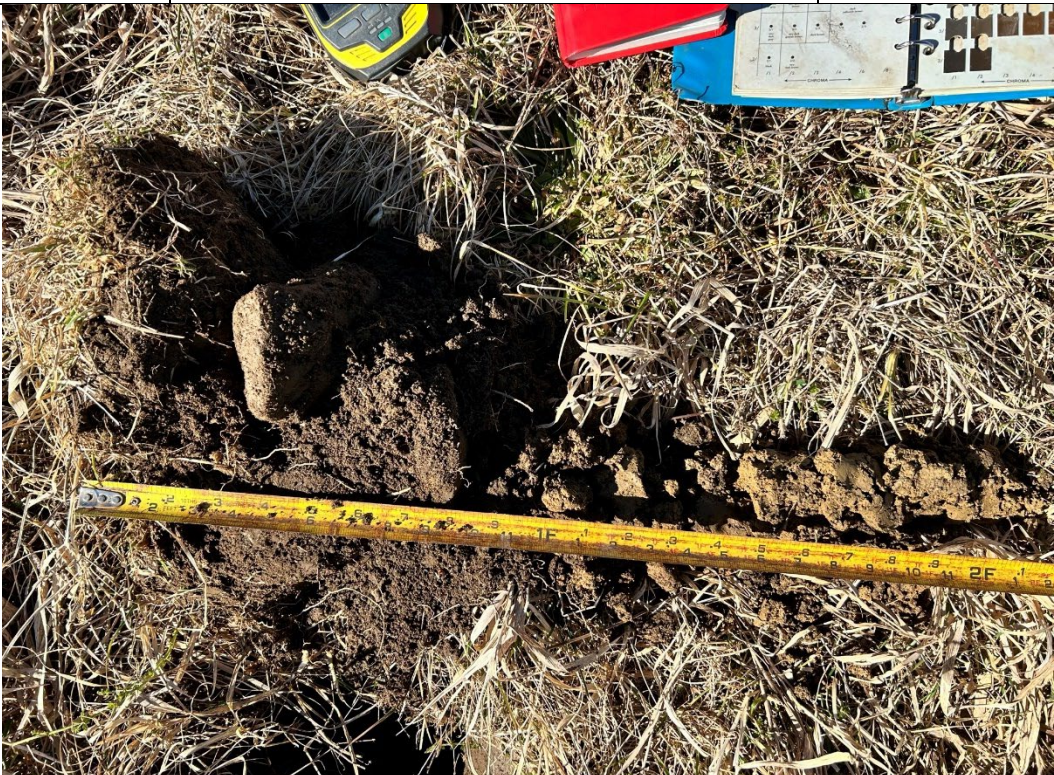
Client Name: Southford Park		Site Location: Timex Site – Middlebury, CT	Project No. 141.20970.00002
Photo No. 1	Date: 2/13/23

Direction Photo Taken: West			
Description: Mowed Field east of Timex Service Road and Building Test Pit #1 Location. Upgradient from Mr. Logan Blue and Green Flag in reed canary grass trough

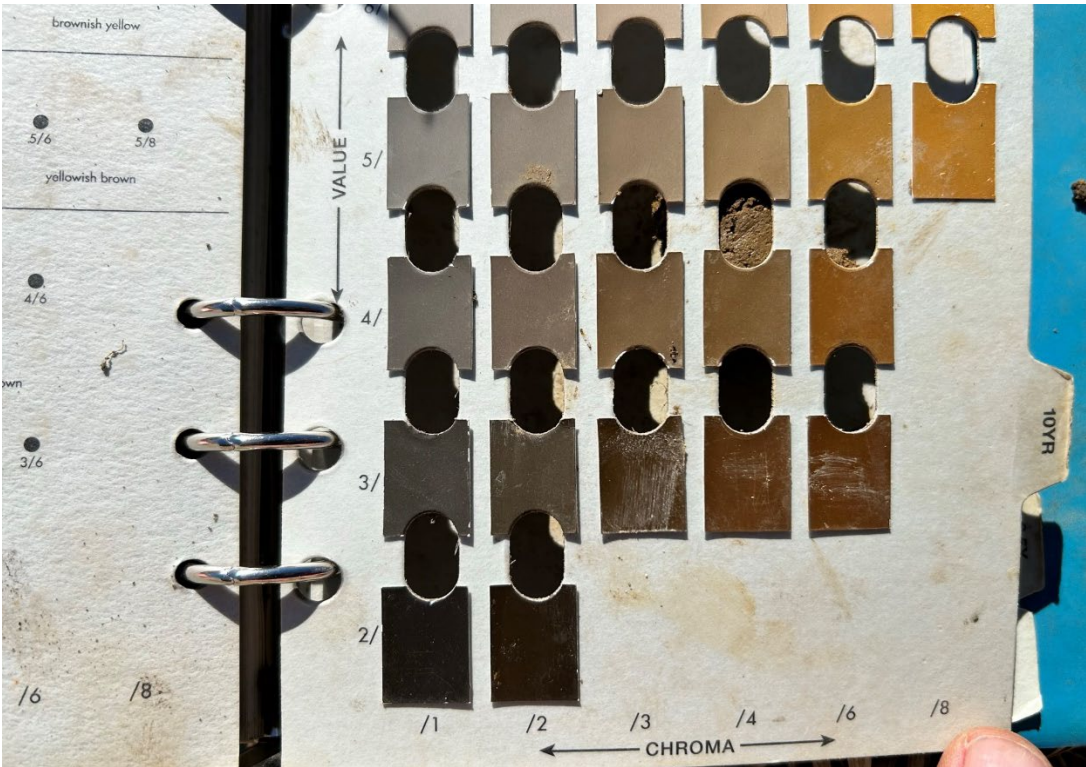
Photo No. 2	Date: 2/13/23

Direction Photo Taken: West		
Description: Mowed Field east of Timex Service Road and Building Test Pit #1 Location. Munsell Color Chart Soil core – 0" to 24" Bw from 12-24'-Matrix Color is 10YR 4/4 – (100%)

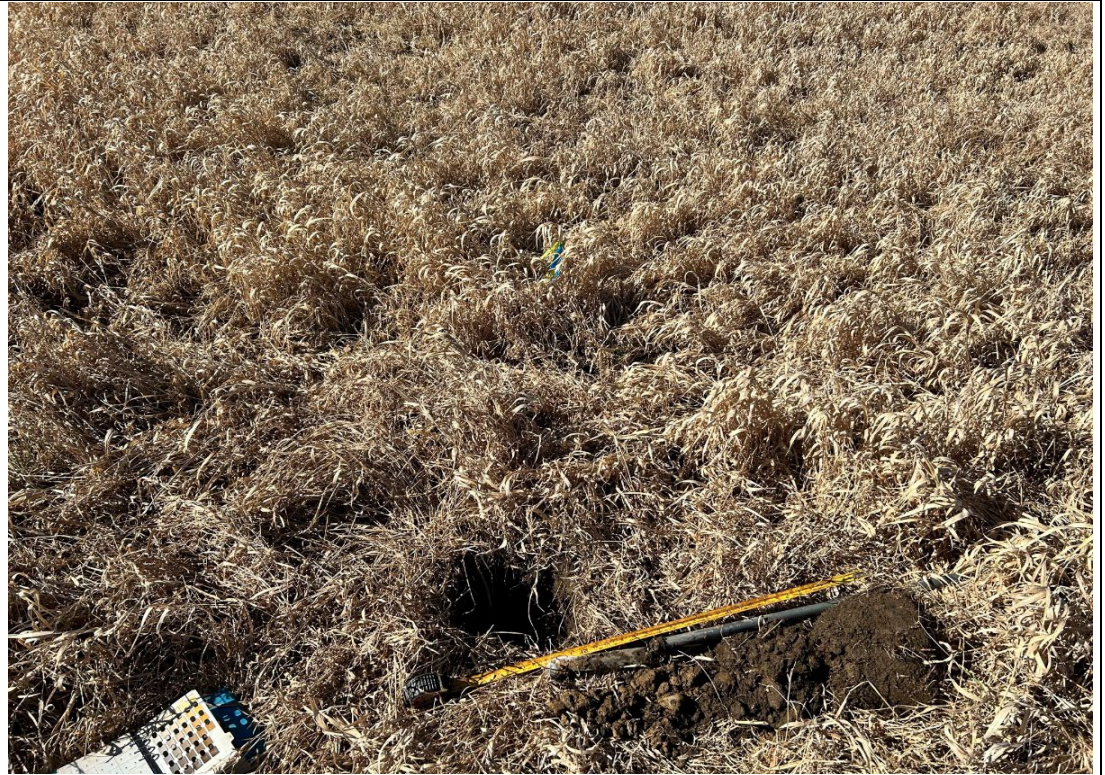
Mowed Field east of Timex Service Road and Building

Test Pit #2 Location.
Mr. Logan Blue and Green Flag in background of hole.
Test Pit core in front of hole.

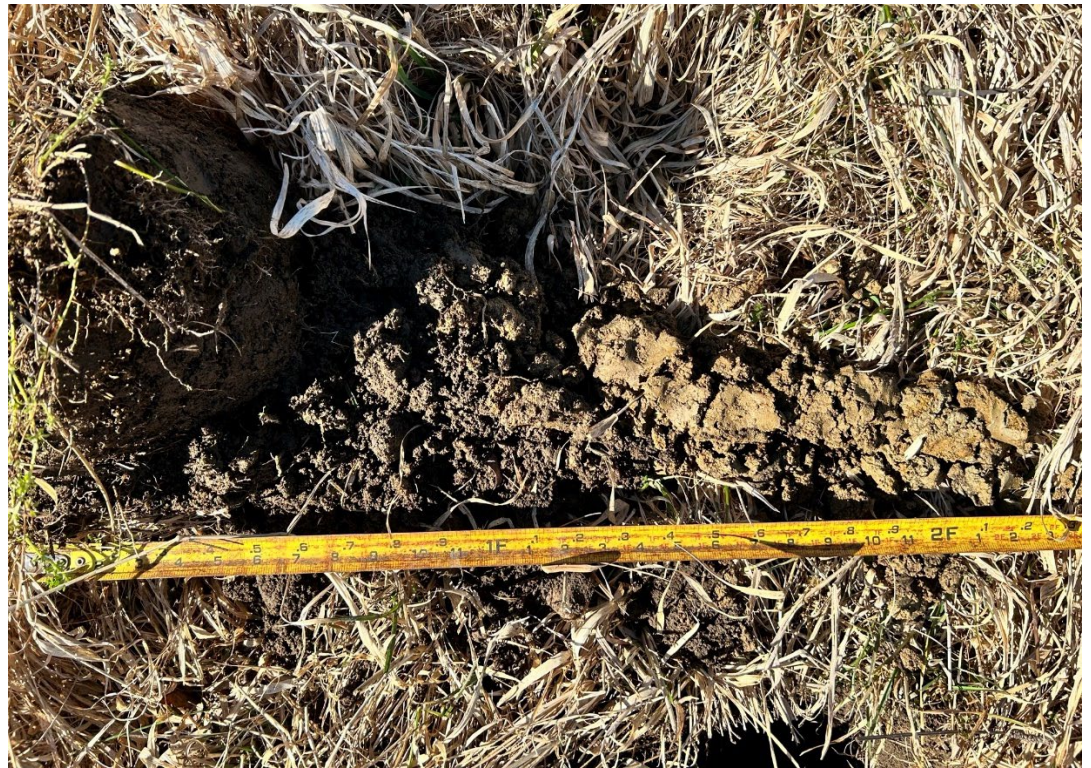
Test Pit #3
Downgradient from Test Pit #2 within reed canary grass trough.

Notice matrix color change at approx. 24" to a 50% 10YR 5/6 and 50% 10YR 6/2 which is showing a depleted matrix. However this matrix begins at 24-inches, therefore this does not qualify as a poorly

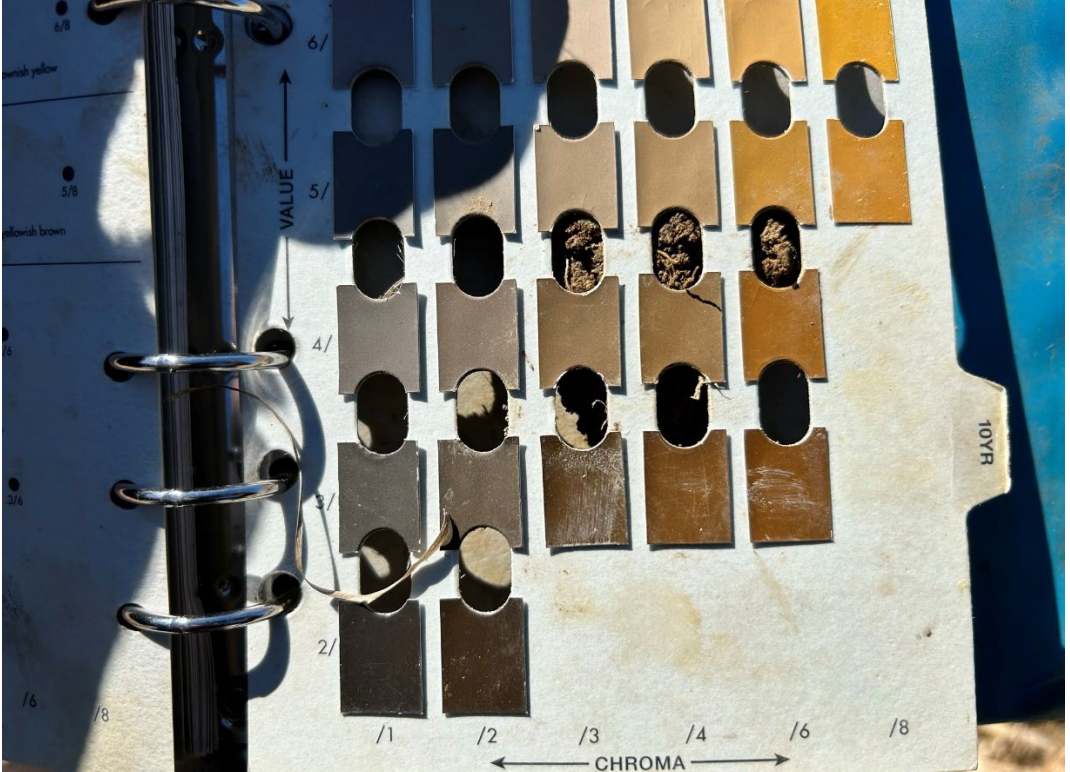
Client Name: Southford Park		Site Location: Timex Site – Middlebury, CT	Project No. 141.20970.00002
Photo No. 9	Date: 1/27/23

Direction Photo Taken: Not Applicable			
Description: Test Pit #4 Munsell Color Chart Dominant matrix color within the B horizon is 10YR 4/3 and 10YR 4/4 between 12" to 24" below the soil surface.

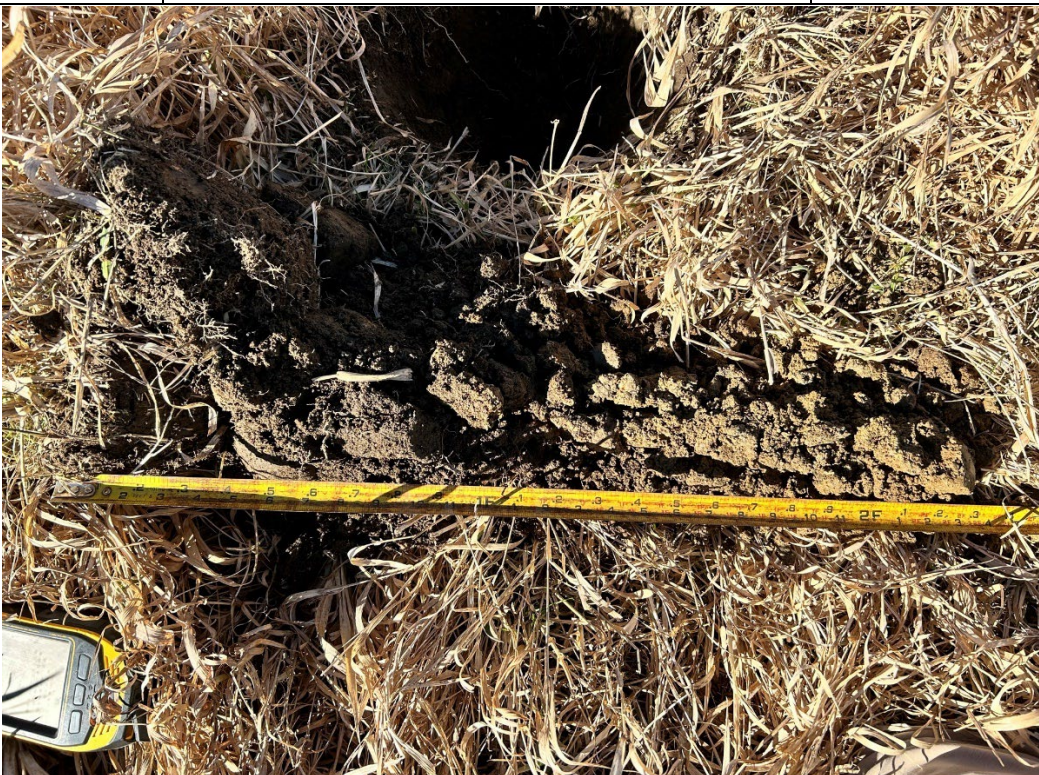
Client Name: Southford Park		Site Location: Timex Site – Middlebury, CT	Project No. 141.20970.00002
Photo No. 11	Date: 2/13/23

Direction Photo Taken: South			
Description: . Test Pit #5 Dominate matrix color changes from 10YR 4/3 to 10YR 5/2 (50%) and 2.5 Y 5/3 (49%) around 12 inches below soil surface and would classify as a poorly drained soil.
