TOWN OF MIDDLEBURY

REGULAR MEETING MINUTES Tuesday, February 28, 2023 7:30 P.M.

SITE/LOCATION: Proposed Southford Park 555 Christian Road & 764 Southford Road Middlebury, Connecticut	REMA JOB NO.: 23-2579-MDL28	ANNOTATED PHOTO LOG
	INVESTIGATOR(S): George T. Logan, MS, PWS, CSE		
DATE: February 18, 2023	FACING: SOUTHWESTERLY	PHOTO NO.: 5

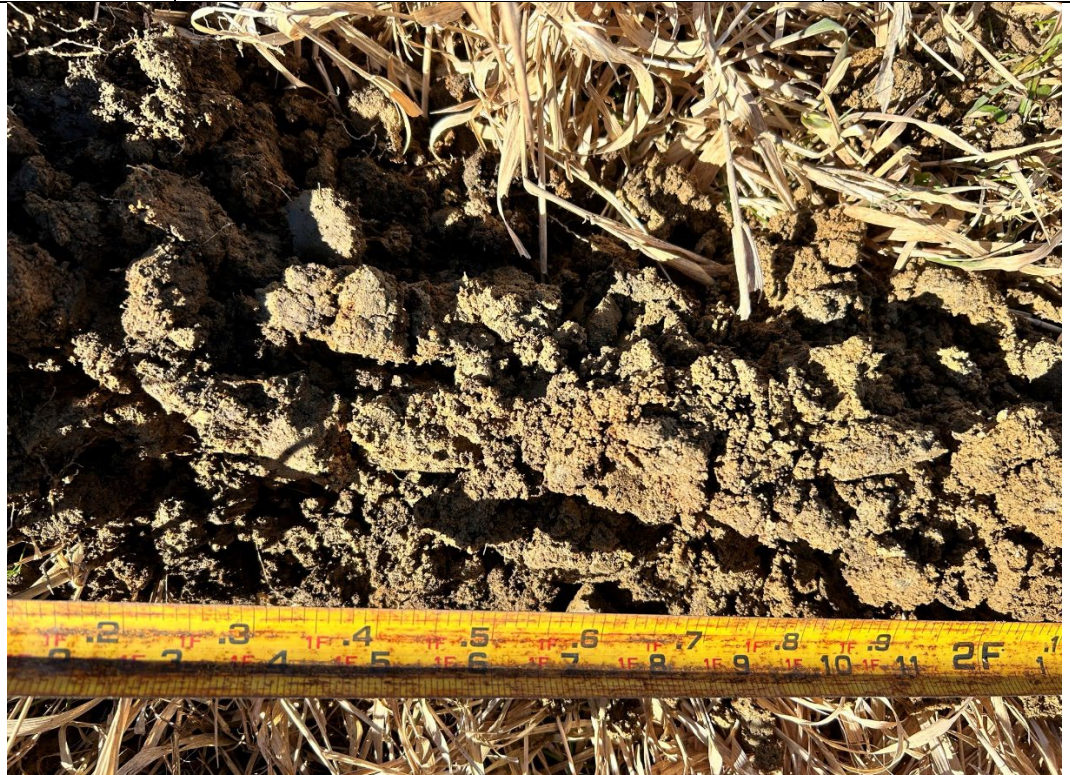
Test Pit #5

Close up of soil with 50% depleted matrix color. .

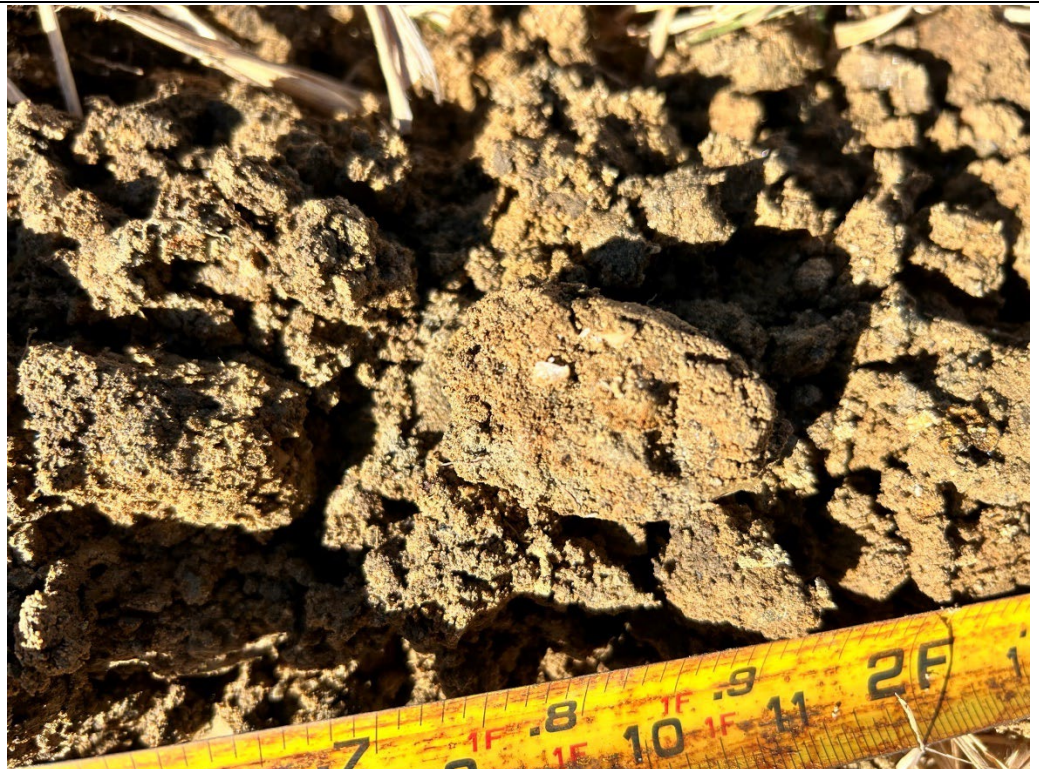
Test Pit #5

Close up of soil with 50% depleted matrix color. .

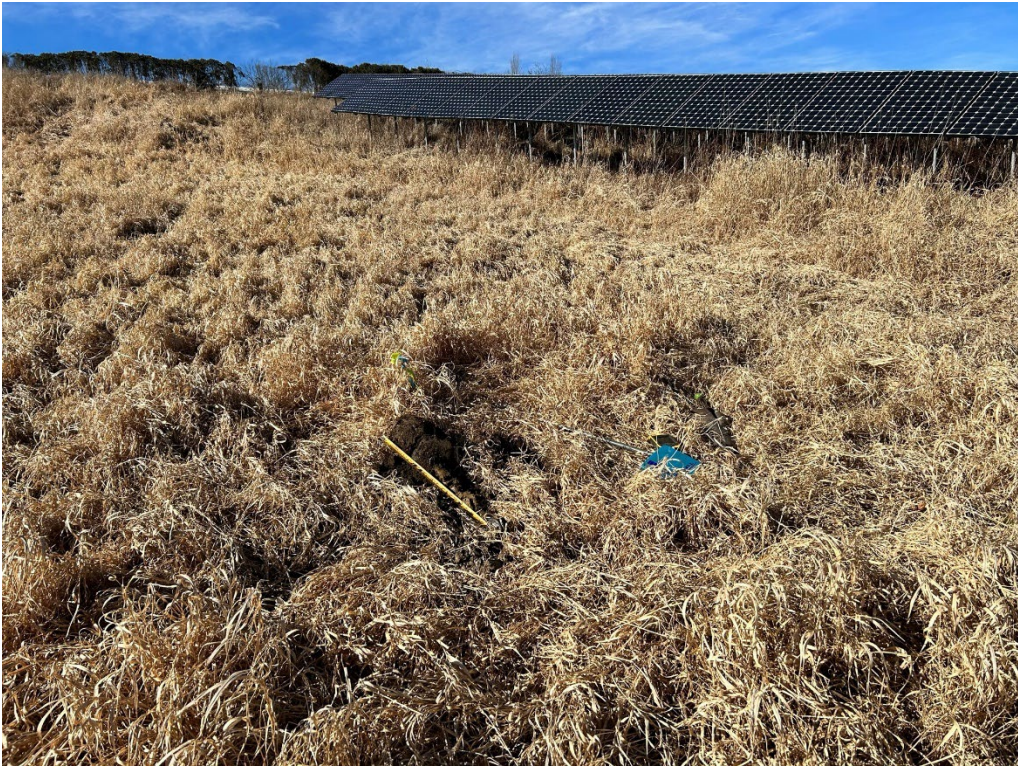
Client Name: Southford Park		Site Location: Timex Site – Middlebury, CT		Project No. 141.20970.00002
Photo No. 15	Date: 2/13/23

Direction Photo Taken: Northwest				
Description: Test Pit #6 Logan Blue/Green Flag in background/upgradient from Test Pit. Another Reed Canary grass trough.

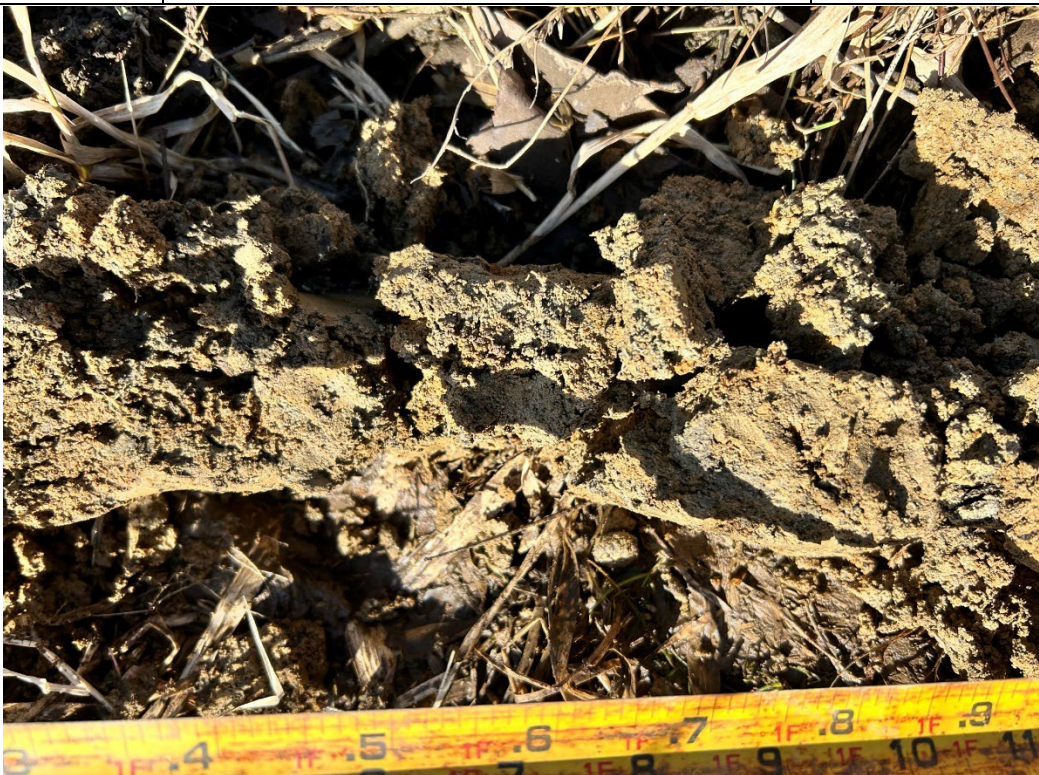
Direction Photo Taken: South			
Description: Test Pit #7 Close up of soil within wetland. 60% depleted matrix color.

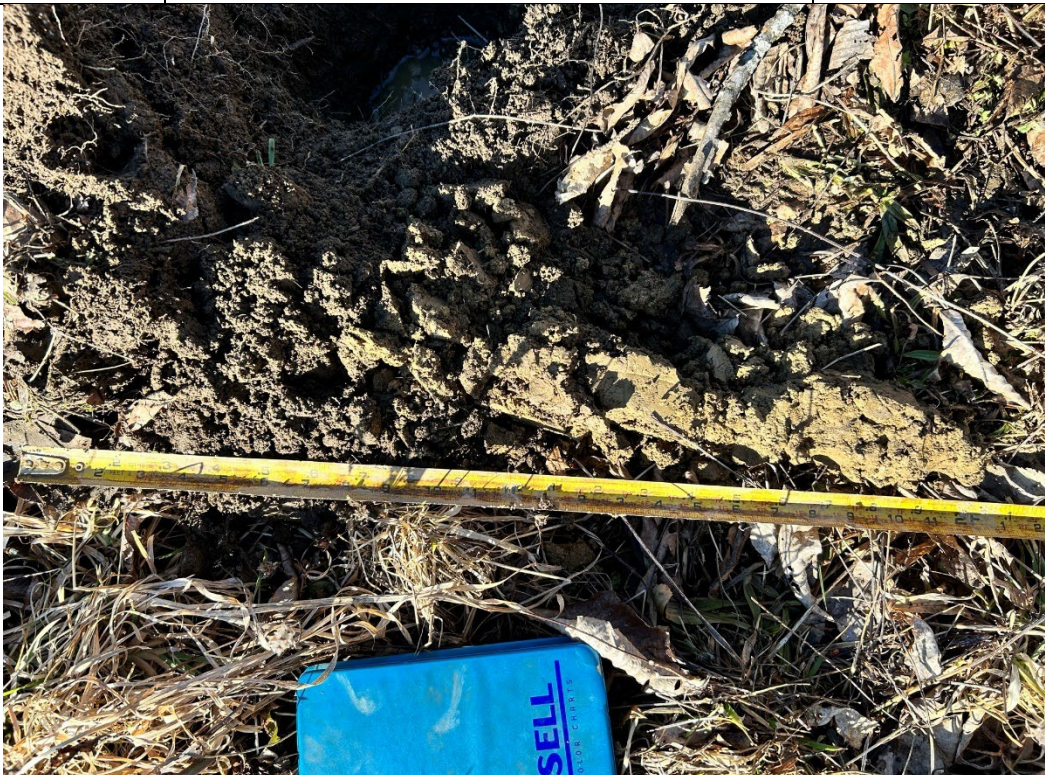
Direction Photo Taken: Not Applicable			
Description: Test Pit #8 Soils between 10" and 24" have a dominate matrix color of 10YR 4/3.

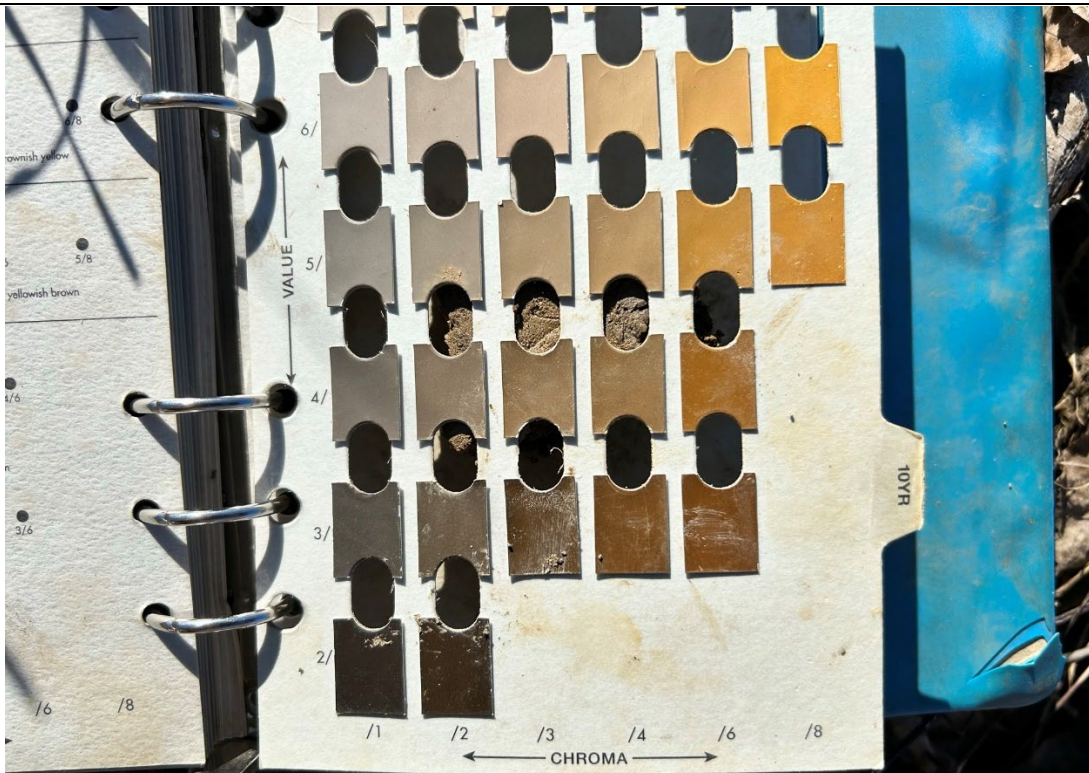
Photo No. 22	Date: 2/13/23

Direction Photo Taken: Not applicable		
Description: Test Pit #8 Munsell Color Chart Dominate matrix color changes from 10YR 4/3 to 10YR 5/2 (50%) and 2.5 Y 5/3 around 12 inches below soil surface and would classify as a poorly drained soil.

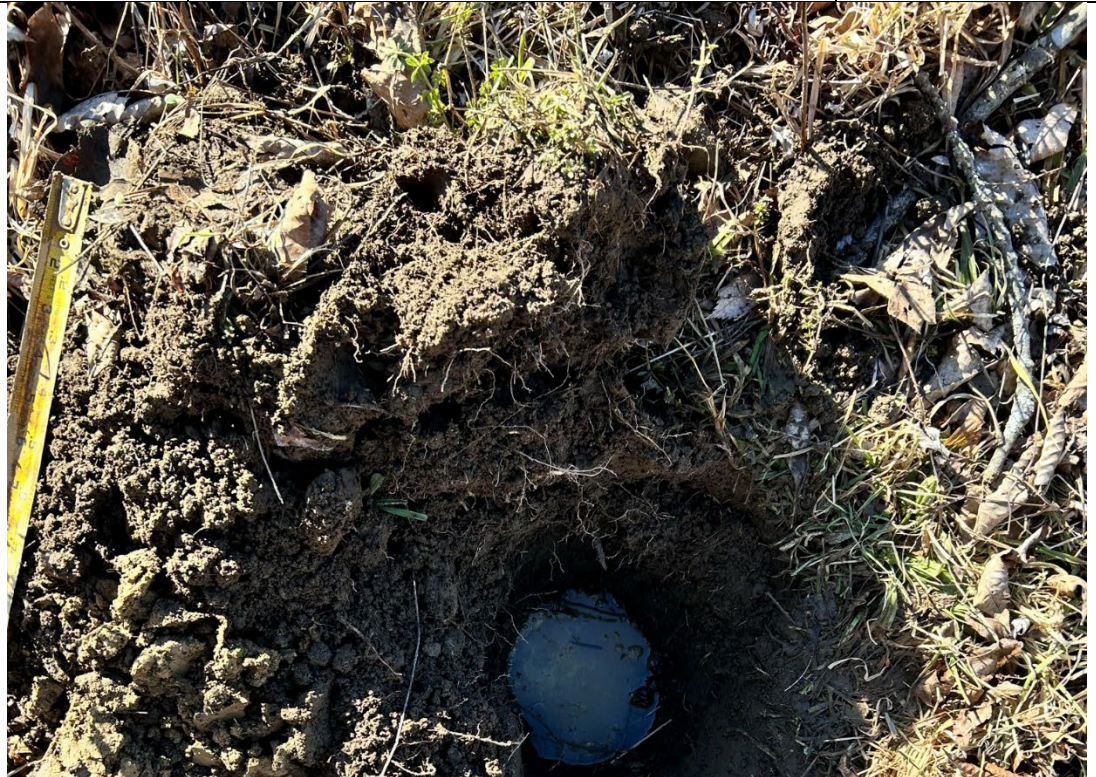
Test Pit #8

Active water table
observed in test pit holw at
approximately 12-inches.

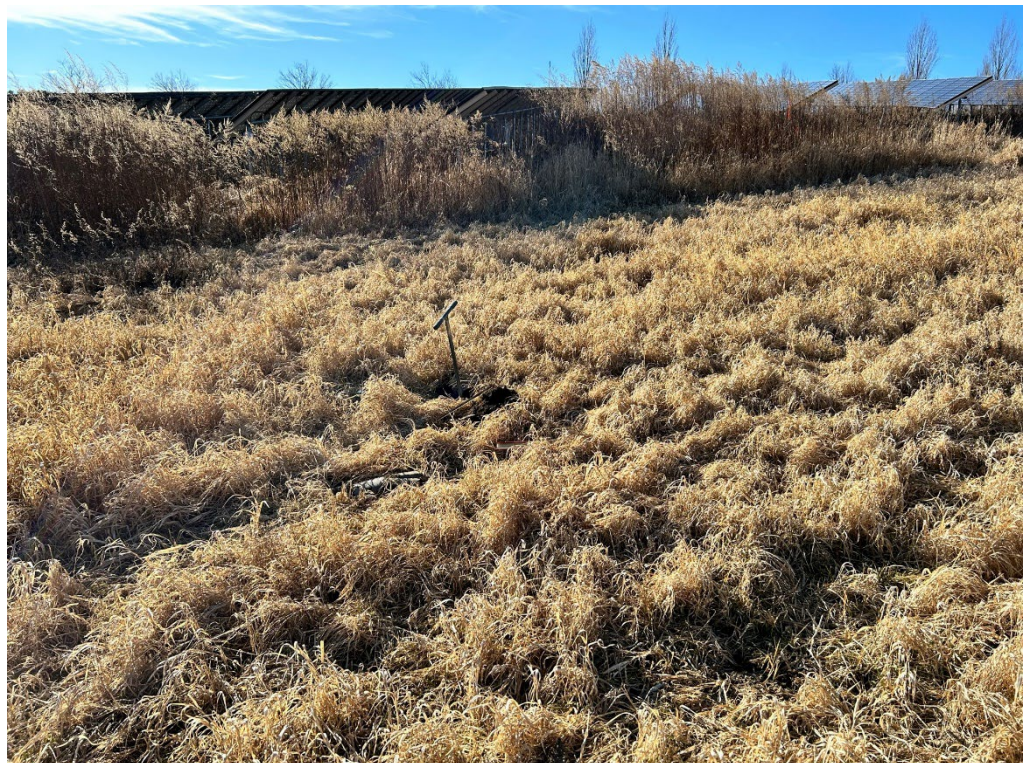
Test Pit #9

Located north side of solar
panels within reed canary
grass patch.

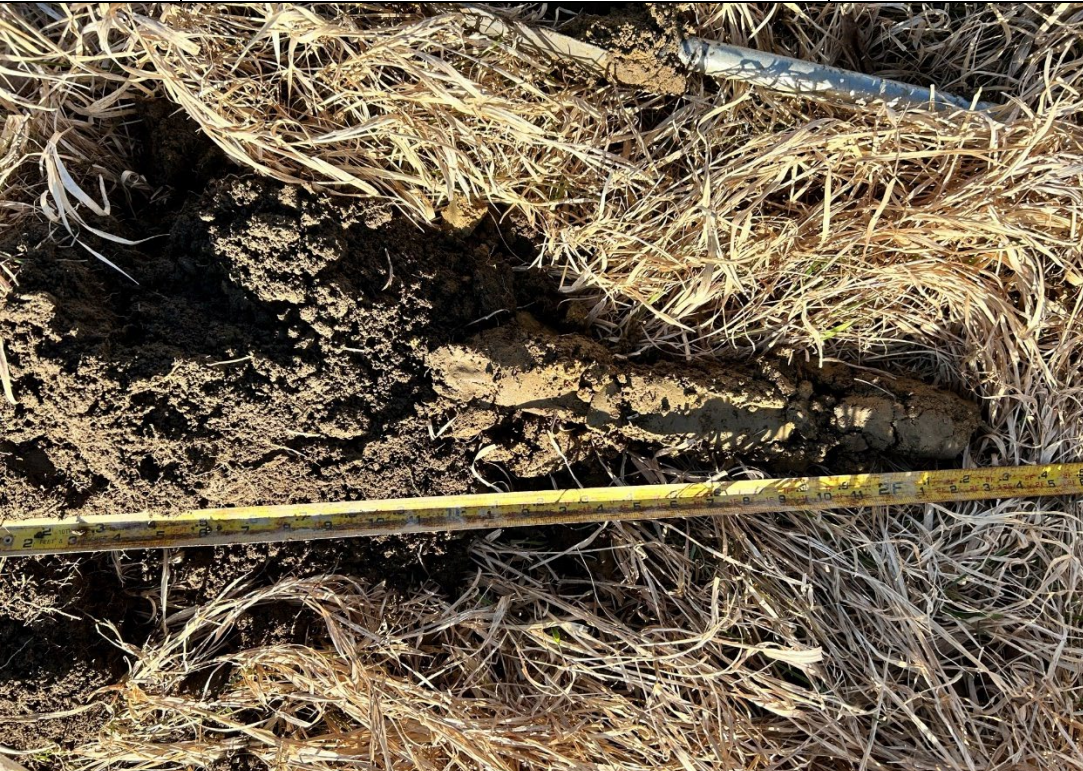
Direction Photo Taken: Not Applicable			
Description: Test Pit #9 Dominant matrix color 10YR 4/3 between 12 and 24 inches below the soil surface.

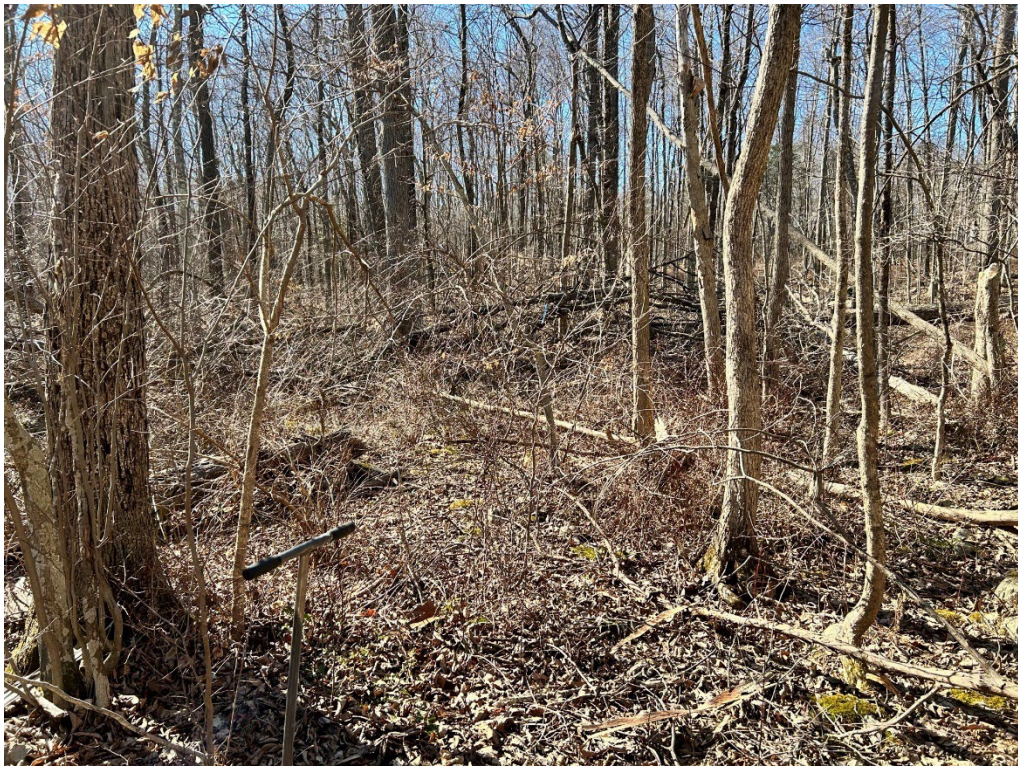
Direction Photo Taken: Northwest			
Description: No revision to wetland boundary based on soil augur holes/cores completed. Mr. Logan's blue flag is located in background.

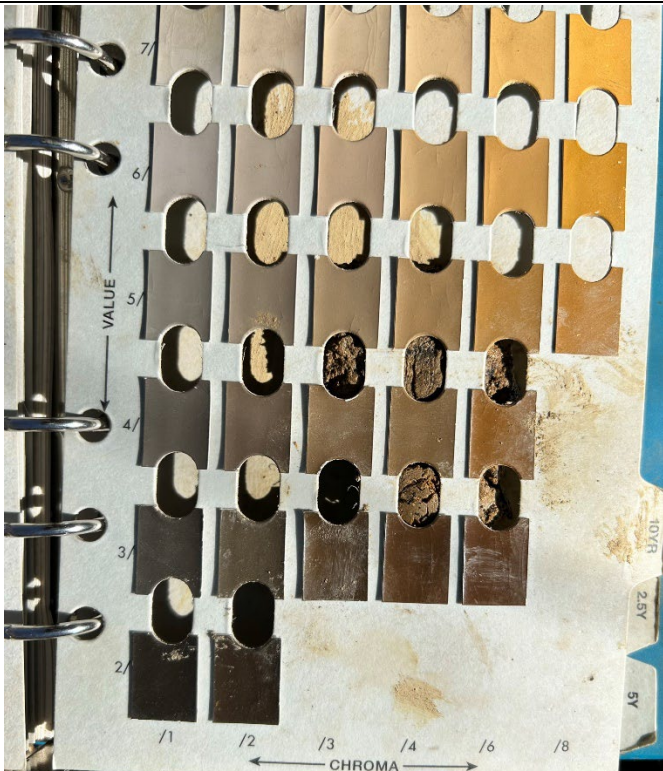
Photo No. 26	Date: 2/13/23

Direction Photo Taken: Not applicable		
Description: Typical dominant matrix color 10YR 4/4 between Mr. Logan's flag and W-B-25 and W-B-26.

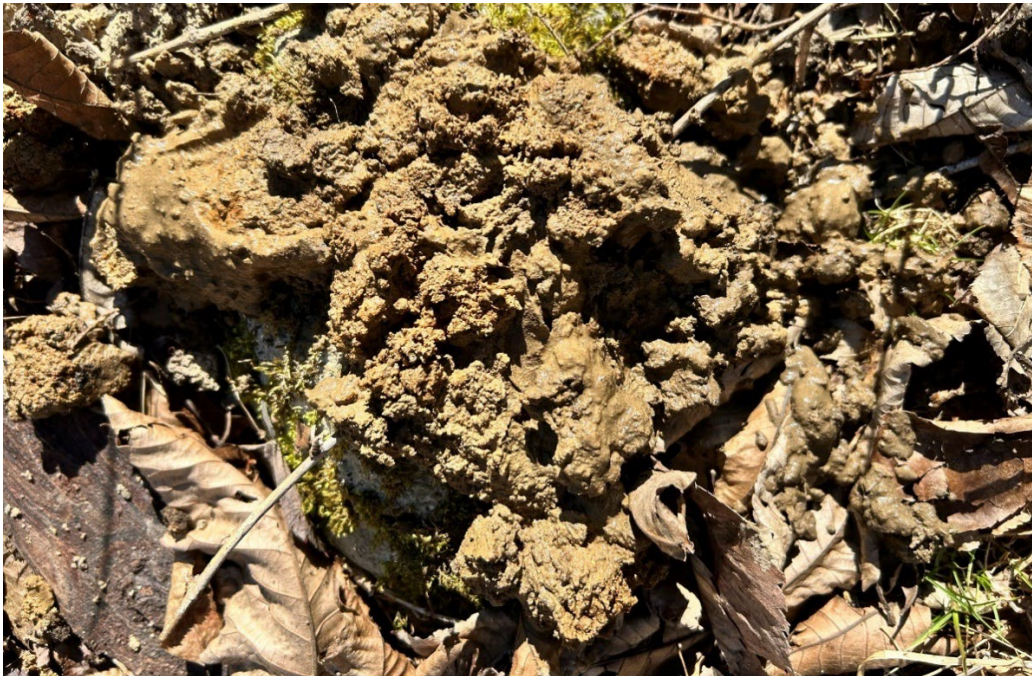
Direction Photo Taken: Not Applicable			
Description: Typical dominant matrix color 10YR 4/4 between Mr. Logan's flag and W-B-25 and W-B-26. This soil collected between 6 and 24 inches. Depletions 10 YR 5/2 are present within upper 24 inches but are less than 50% of the matrix color. Water table was observed at 12 inches and soil was soupy upon extraction.

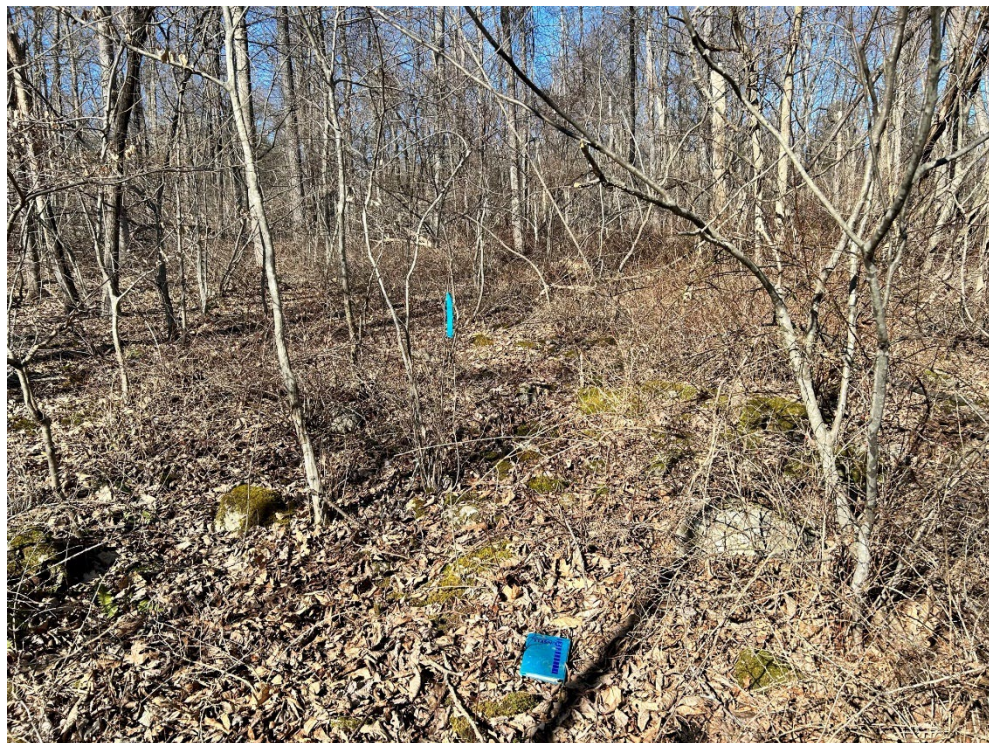
Direction Photo Taken: Norrthwest			
Description: Mr. Logans blue flag located west of wetland flag W-B-23. SLR moved our November 2022 W-B-23 flag out to Mr. Logans blue flag location.

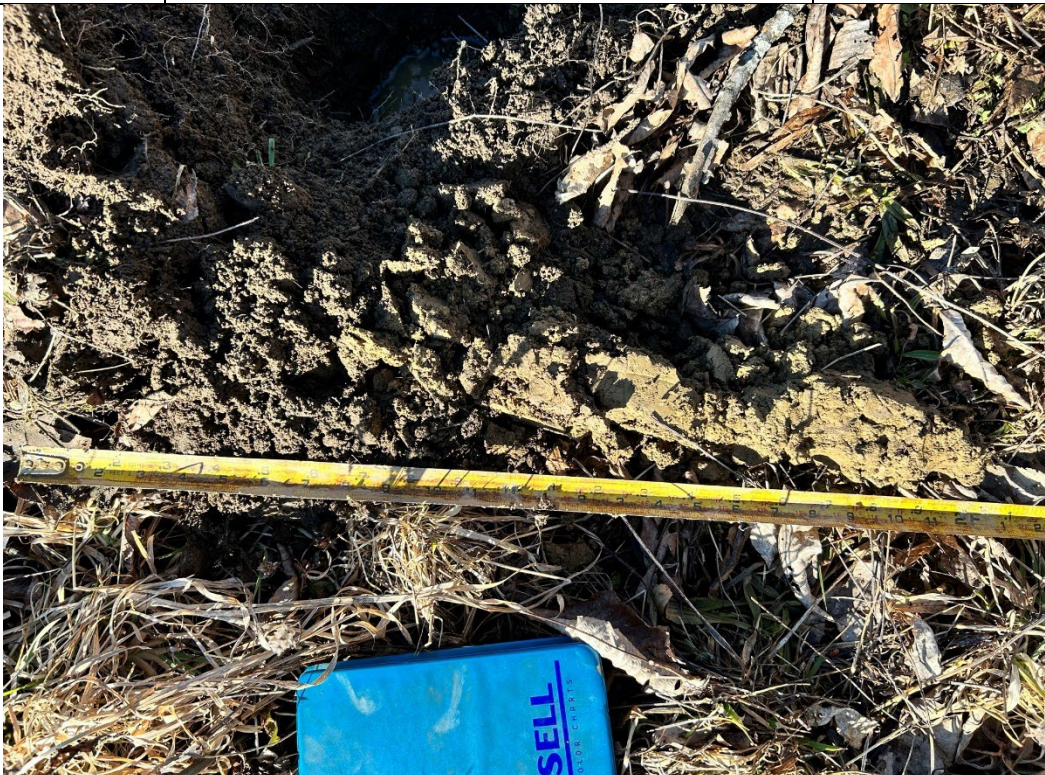
Direction Photo Taken: Not Applicable			
Description: Test Pit #8 Soils between 10" and 24" have a dominate matrix color of 10YR 4/3.

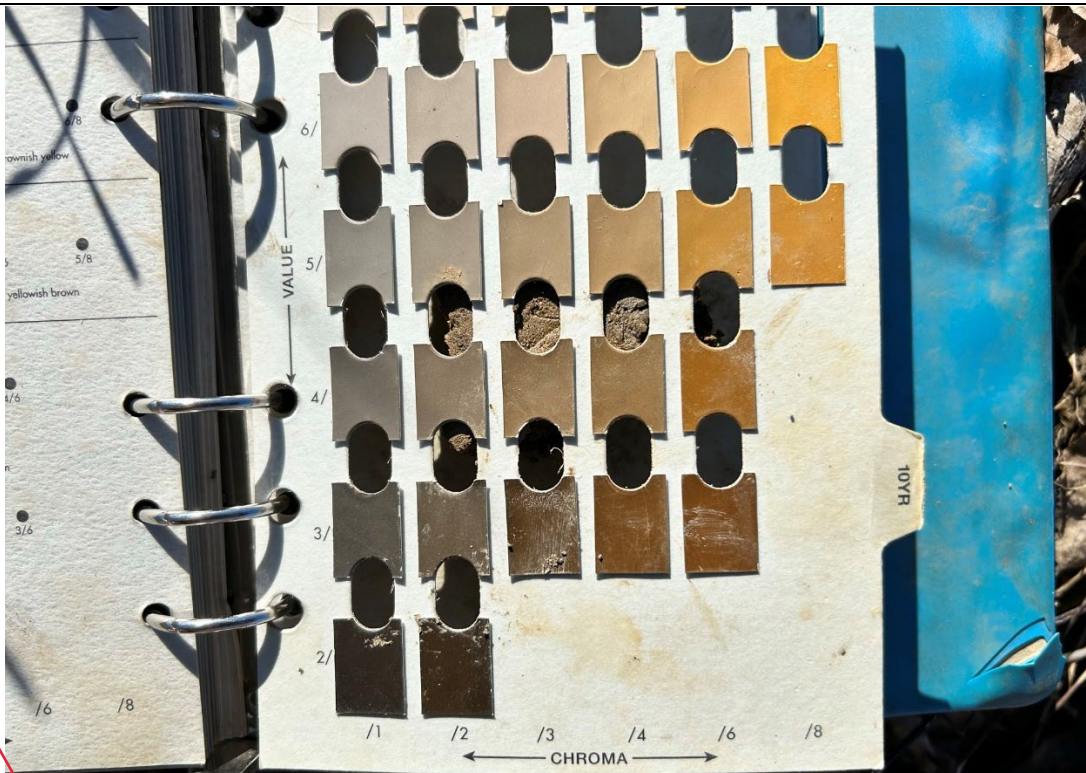
Direction Photo Taken: Not applicable		
Description: Test Pit #8 Munsell Color Chart Dominate matrix color is 10YR 4/3 (100%). No redox present within upper 24 inches of soil solum.

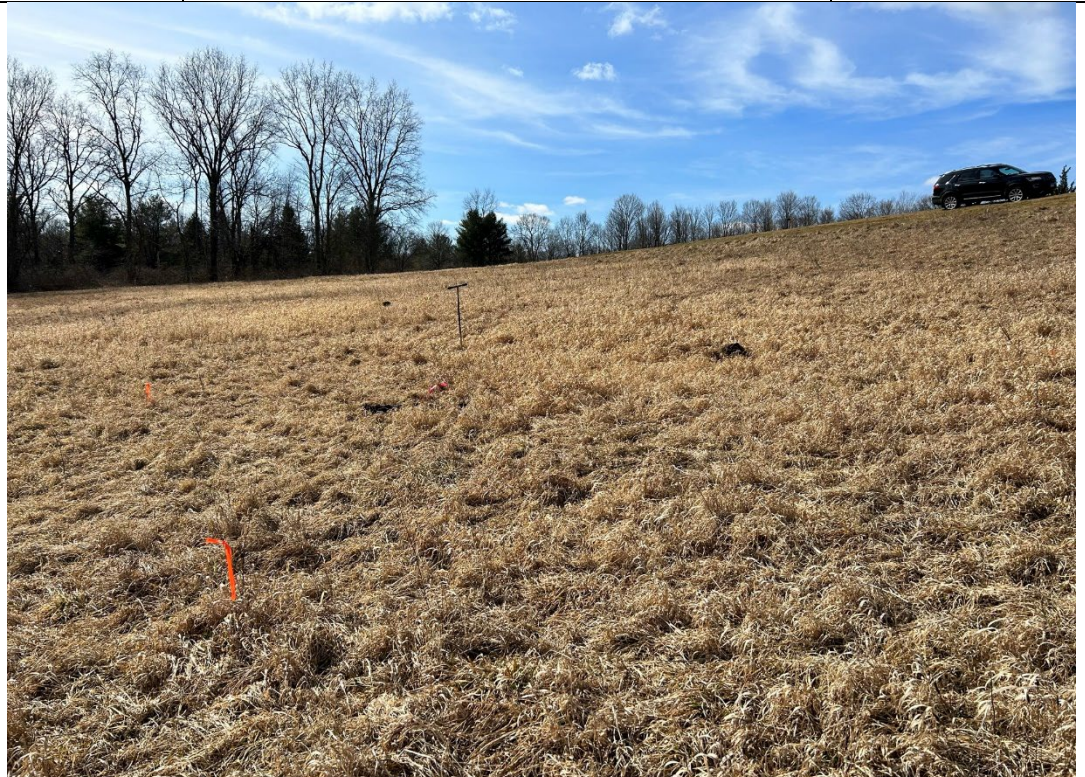
Mowed Field east of Timex Service Road and Building

Wetland WM added flags WM-5 and WM-6 downgradient from WM-2 and WM-4

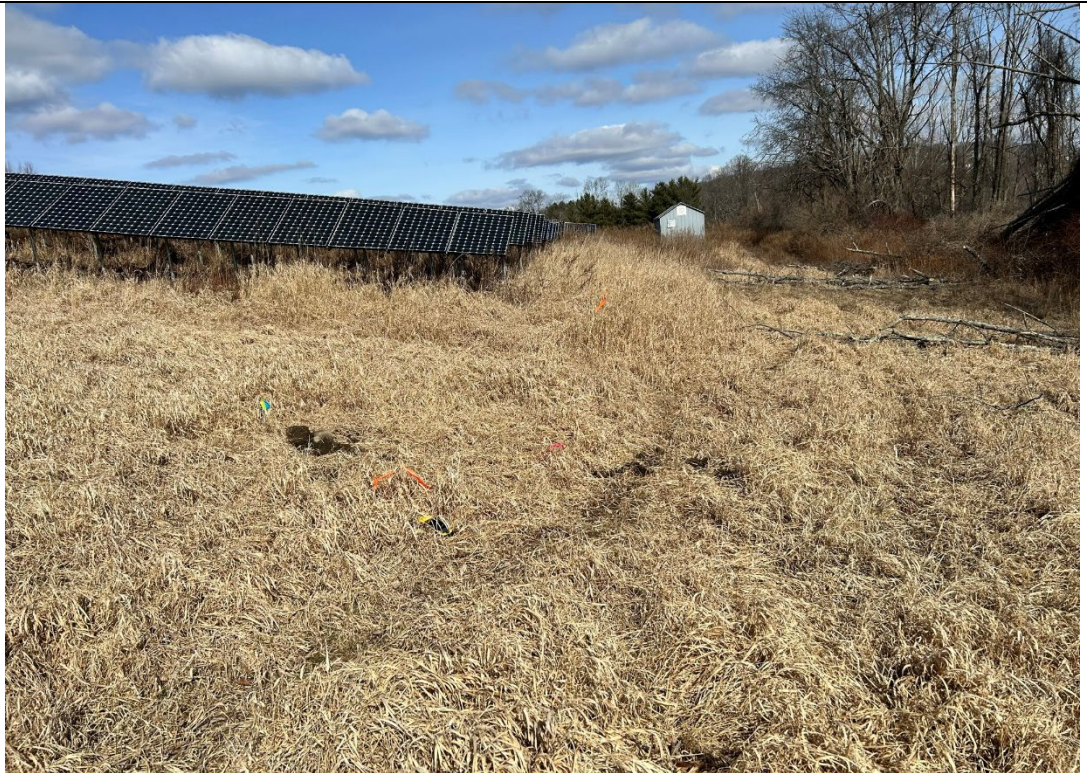
Wetland WF

Extended flags uphill by approximately 15 and 16 feet respectively. Reset wetland flags WF-1 and WF-2. Flags were set between Logan's Blue/Green flag and his pink test pit flag.

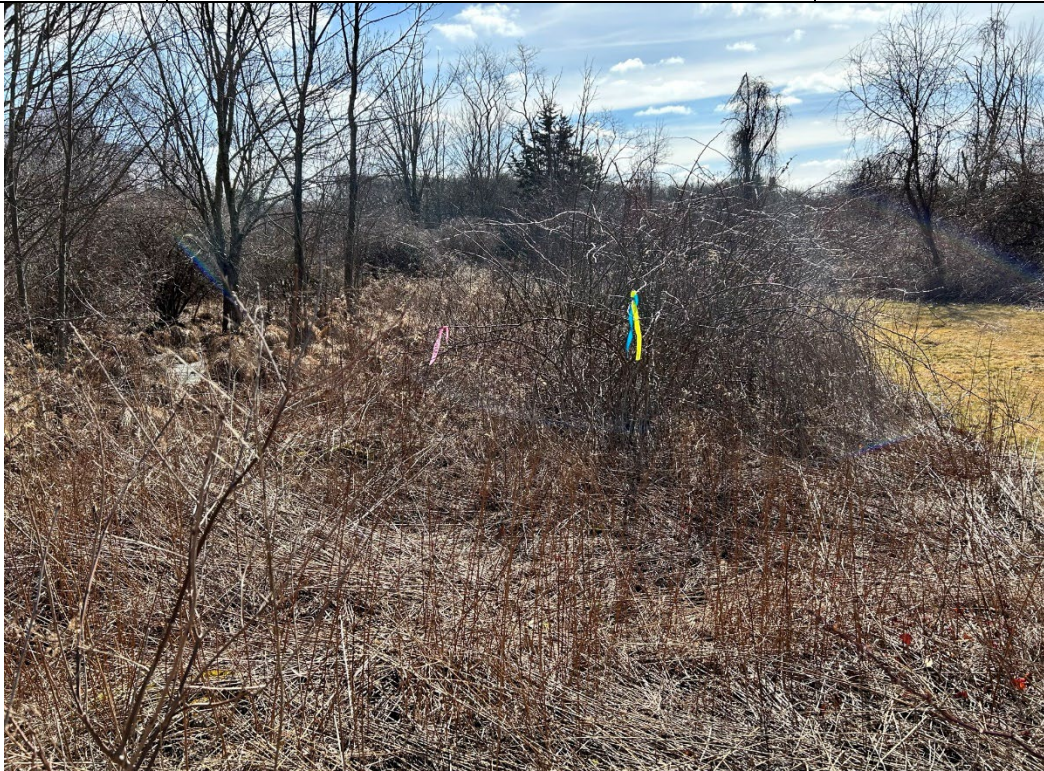
Client Name: Southford Park		Site Location: Timex Site – Middlebury, CT	Project No. 141.20970.00002
Photo No. 3	Date: 2/27/23

Direction Photo Taken: South			
Description: Federal Wetland A Wetland Flag WZ-197 placed by SLR on February 14, 2023 and George Logan Blue/Green Flag that he placed on February 18, 2023 along west side of Federal Wetland A

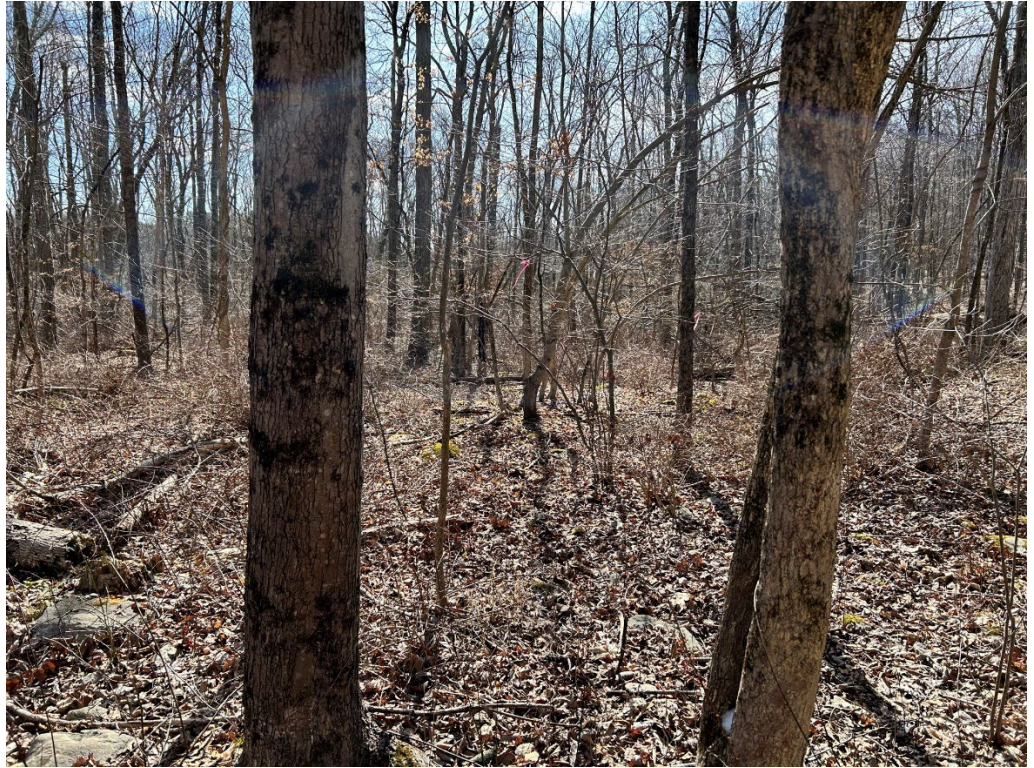
Direction Photo Taken:
East

Description:
Delineated additional Wetland WT on February 27, 2023 and is represented by flags WT-1 through WT-13. Forested slope wetland.

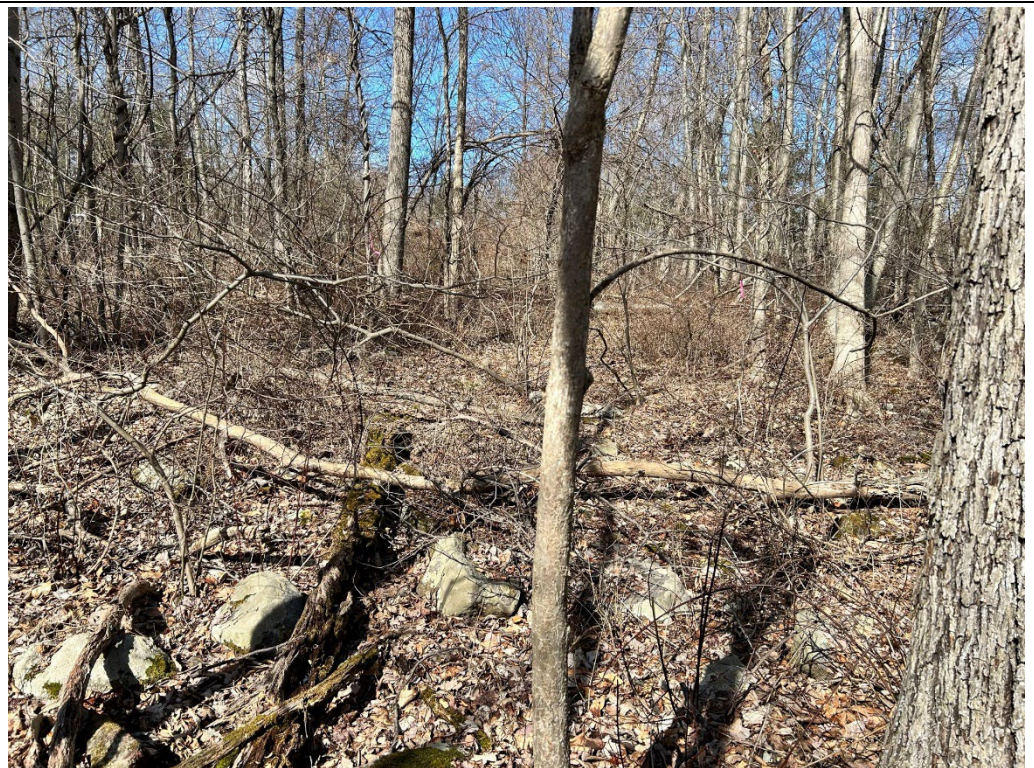
Photo No.
6

Description:
Wetland WT represented by flags WT-1 through WT-13. Forested slope wetland.
