# 555 CHRISTIAN ROAD AND 764 SOUTHFORD ROAD WETLAND DELINEATION

## SOIL SCIENTIST REPORT

**555 Christian Road and 764 Southford Road  
Wetland Delineation  
Middlebury, Connecticut  
Soil Scientist Report**

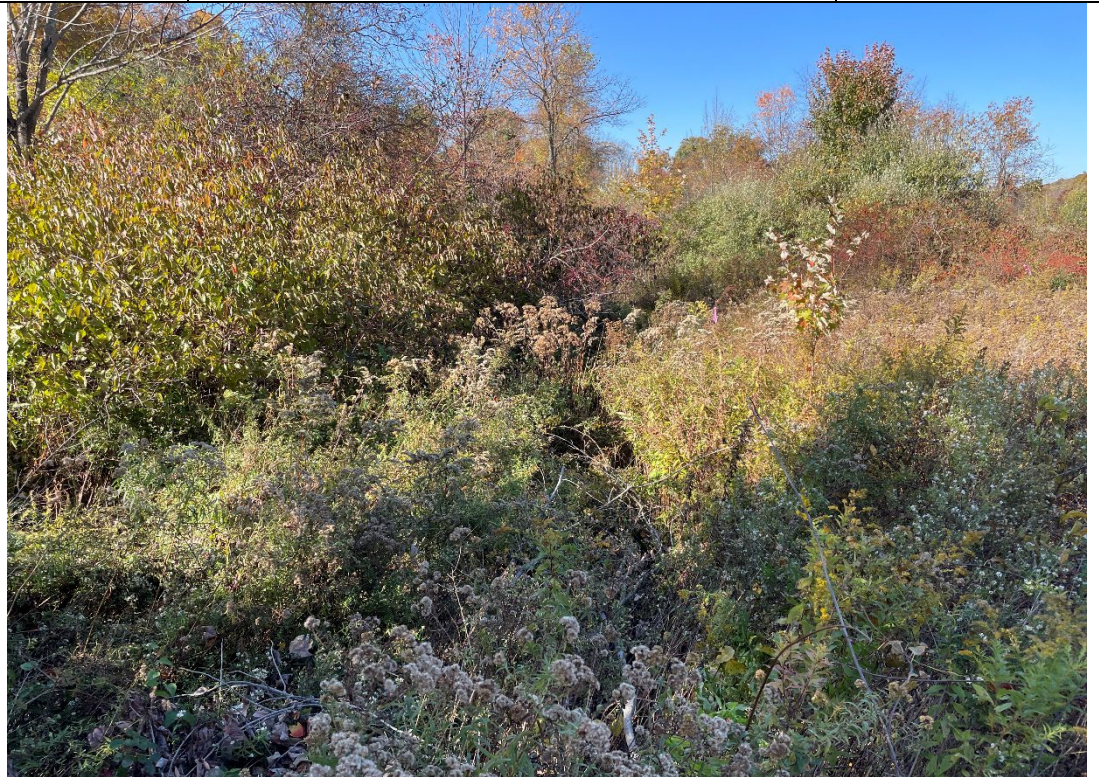
**Direction Photo Taken:**  
Northwest

**Description:**  
View of Federal Wetland A narrow, scrub shrub riparian wetland bordering the eastern bank of the manmade ditch, downstream (north) of the Timex Road culvert crossing.

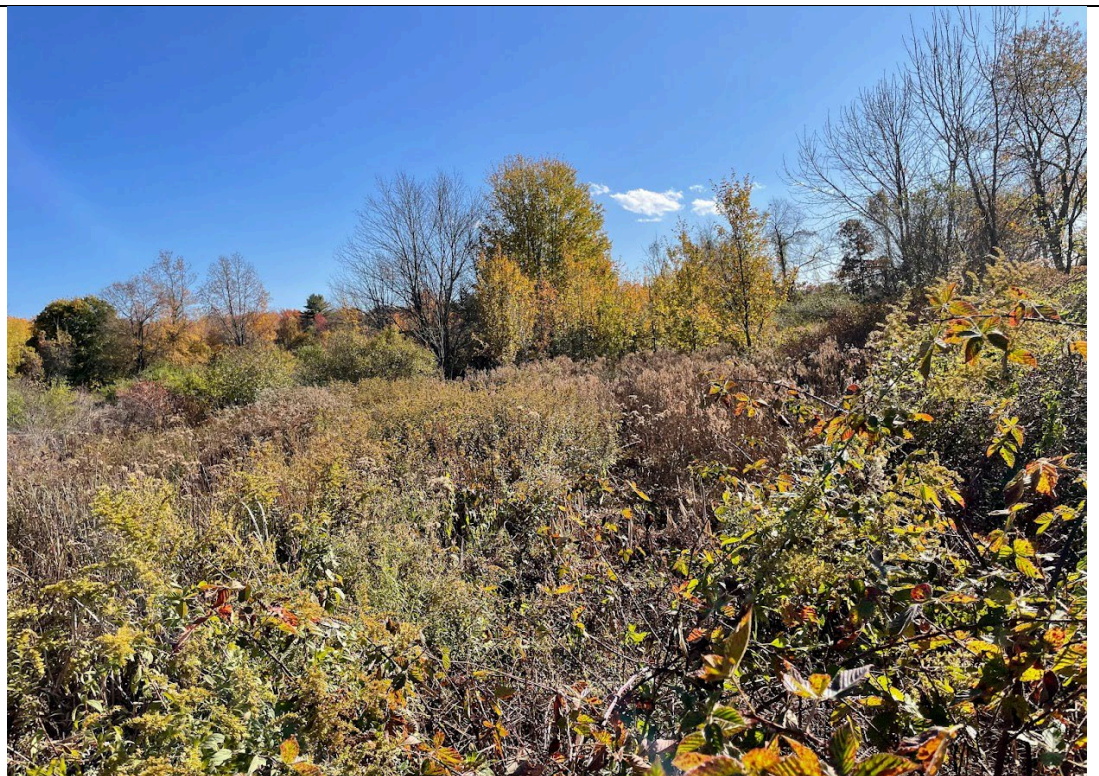
<b>Photo No.</b> 2	<b>Date:</b> 10/18/2022
-----------------------	----------------------------

**Direction Photo Taken:**  
Southeast

**Description:**  
View of Federal Wetland A from the vicinity of the Timex Road culvert crossing, facing upstream.

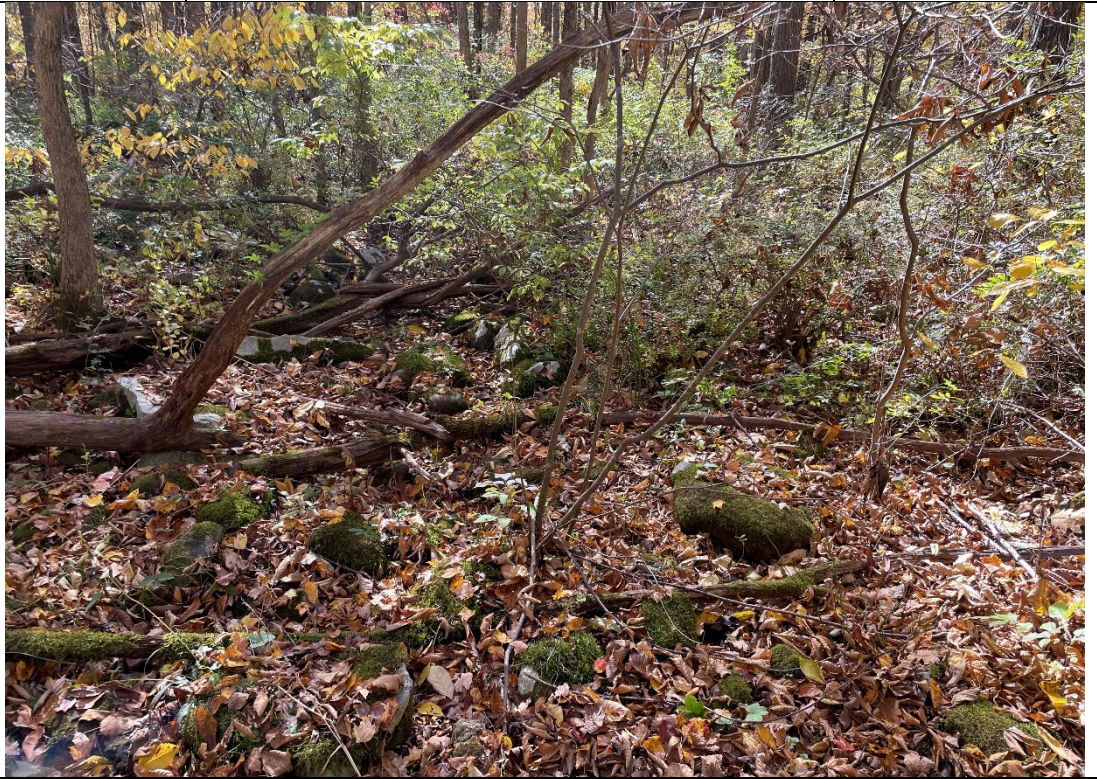
<b>Photo No.</b> 3	<b>Date:</b> 10/18/2022
<b>Direction Photo Taken:</b> East

**Description:**  
View from within the northern, palustrine forested portion of Federal Wetland B, looking towards narrow intermittent watercourse

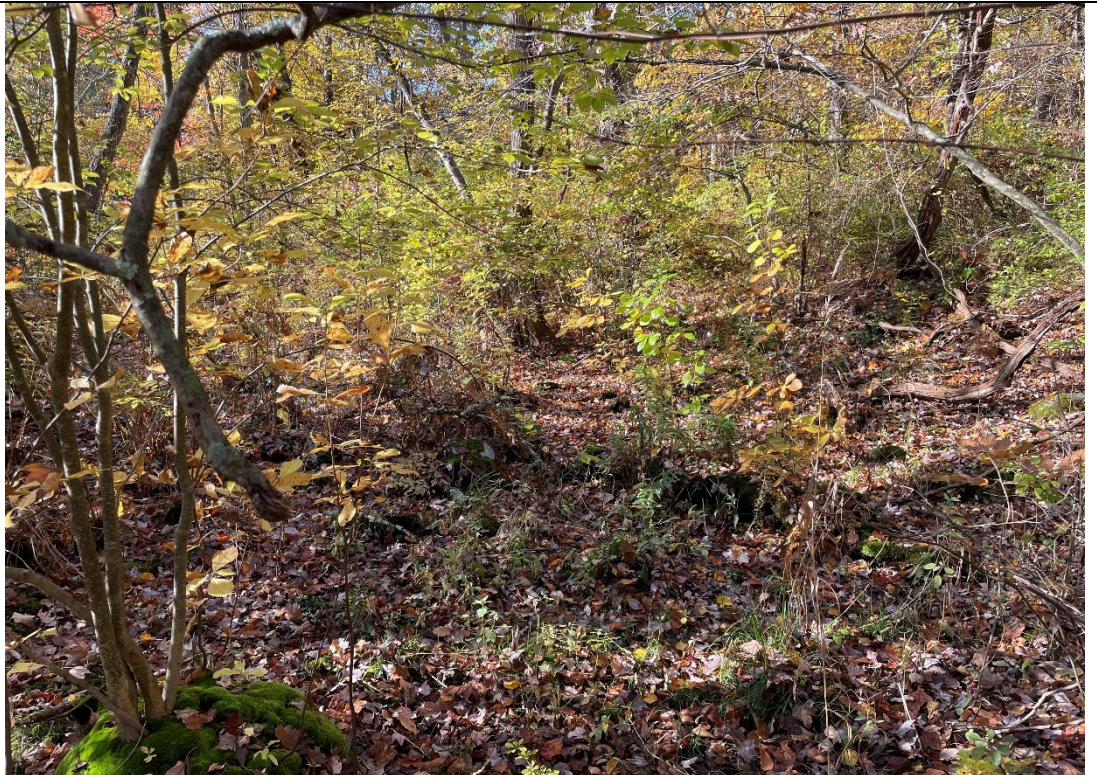
<b>Photo No.</b> 4	<b>Date:</b> 10/18/2022
<b>Direction Photo Taken:</b> South

**Description:**  
View of southern, scrub shrub portion of Federal Wetland B.

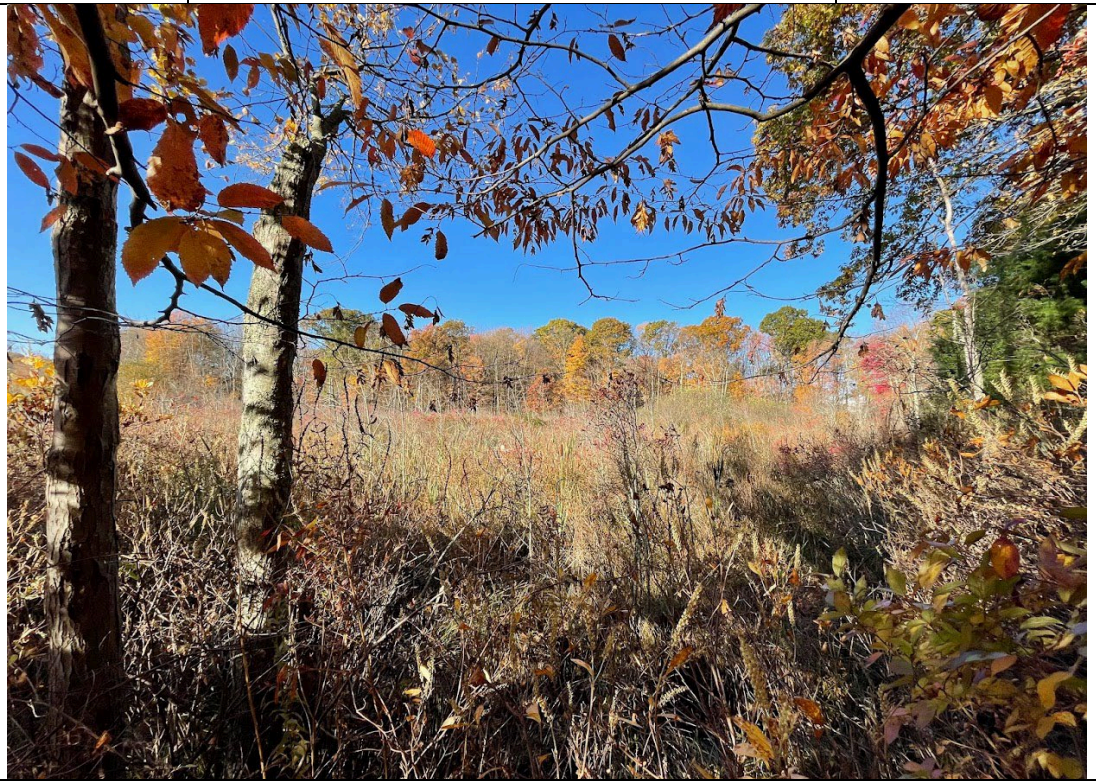
**Direction Photo Taken:**  
Southwest

**Description:**  
Federal Wetland C near the southwest boundary of 764 Southford Rd.

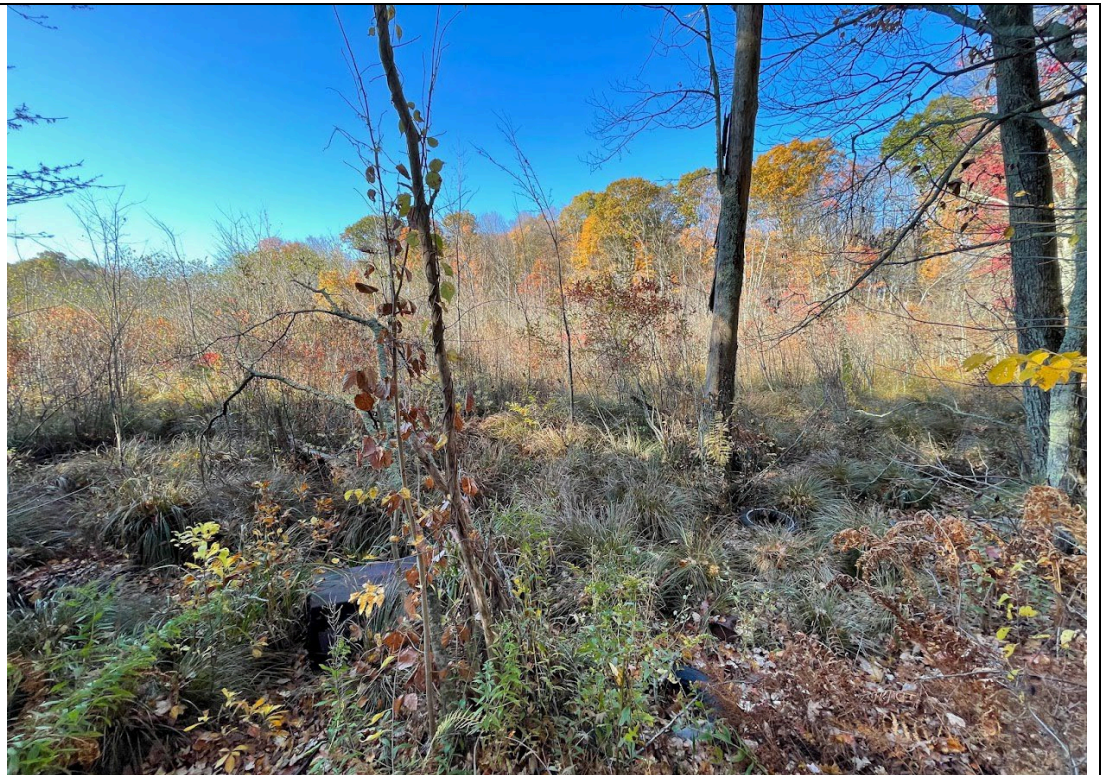
<b>Photo No.</b> 6	<b>Date:</b> 10/18/2022
-----------------------	----------------------------

**Direction Photo Taken:**  
West

**Description:**  
Federal Wetland C with pockets of scrub-shrub (background) and emergent (foreground) vegetation.

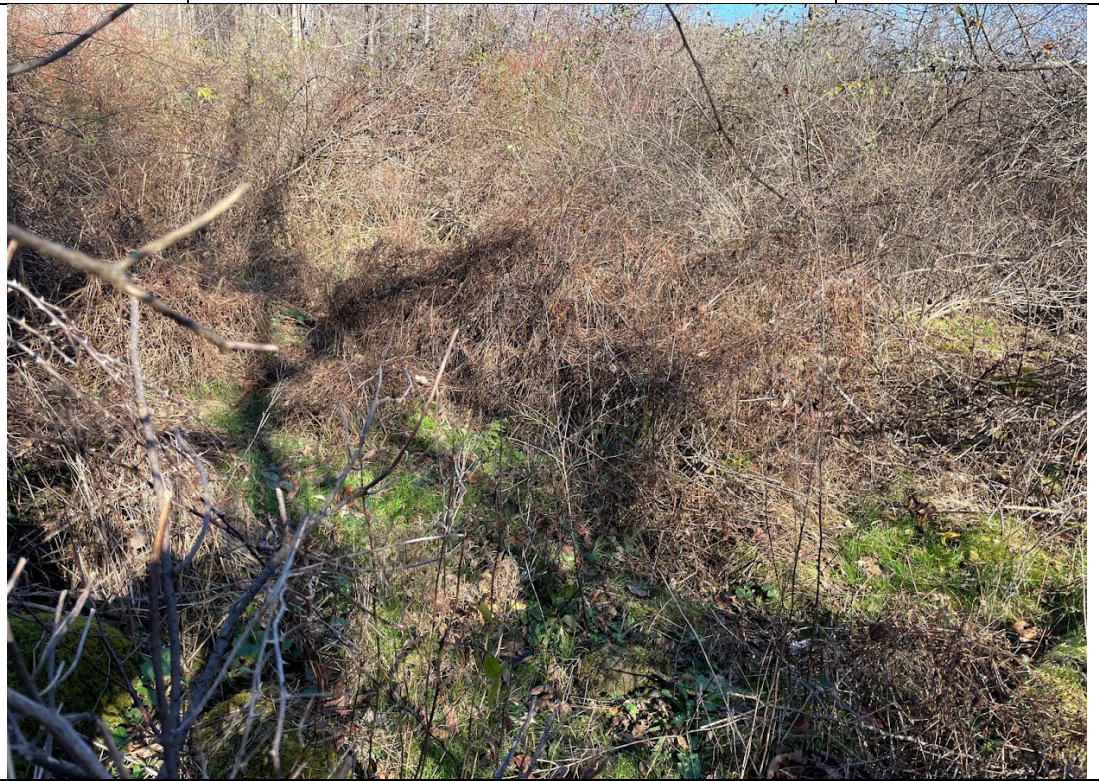
**Direction Photo Taken:**  
East

**Description:**  
View of State Wetland A, an isolated scrub-shrub and emergent depressional wetland.

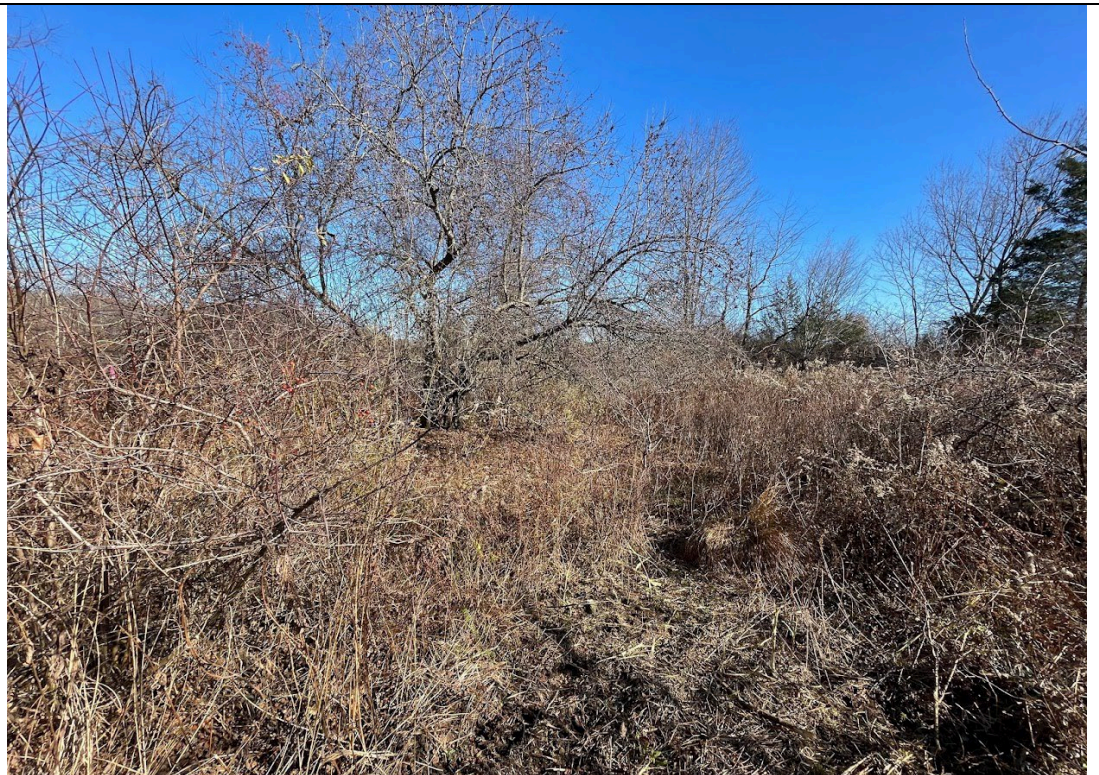
<b>Photo No.</b> 8	<b>Date:</b> 10/18/2022
-----------------------	----------------------------

**Direction Photo Taken:**  
East

**Description:**  
View of State Wetland B, an isolated scrub-shrub depressional wetland.

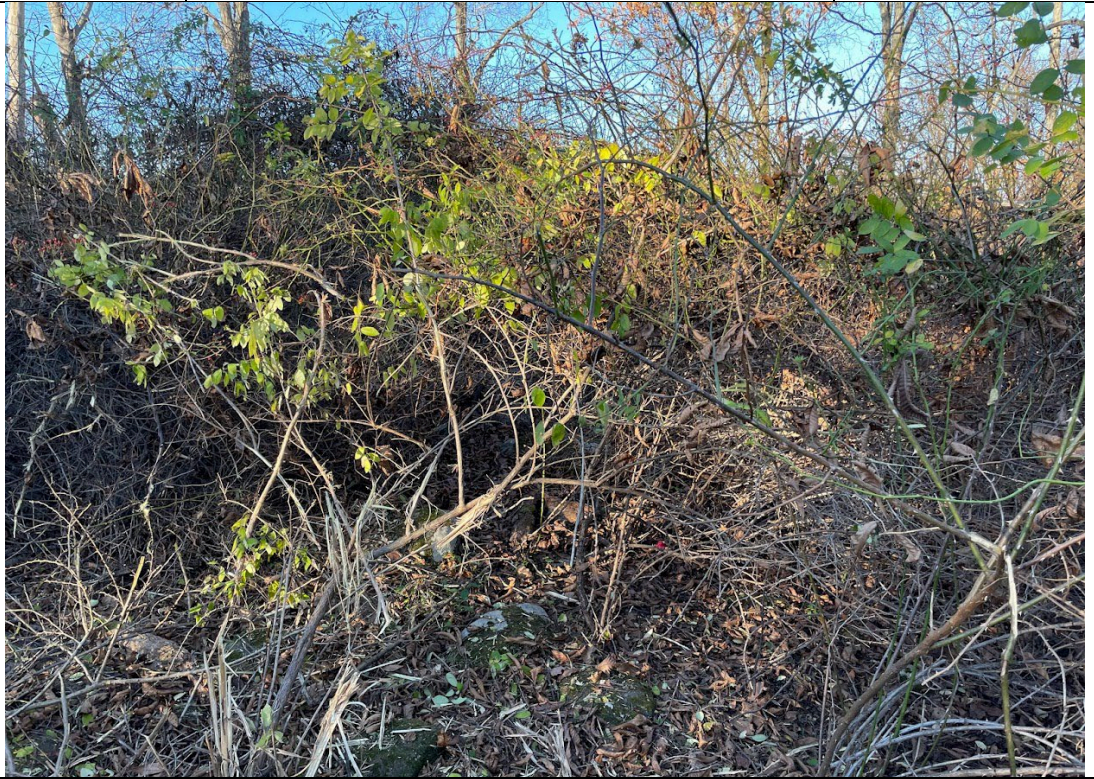
**Direction Photo Taken:**  
Northeast

**Description:**  
View of State Wetland C, an isolated forested wetland comprised primarily of non-native vegetation.

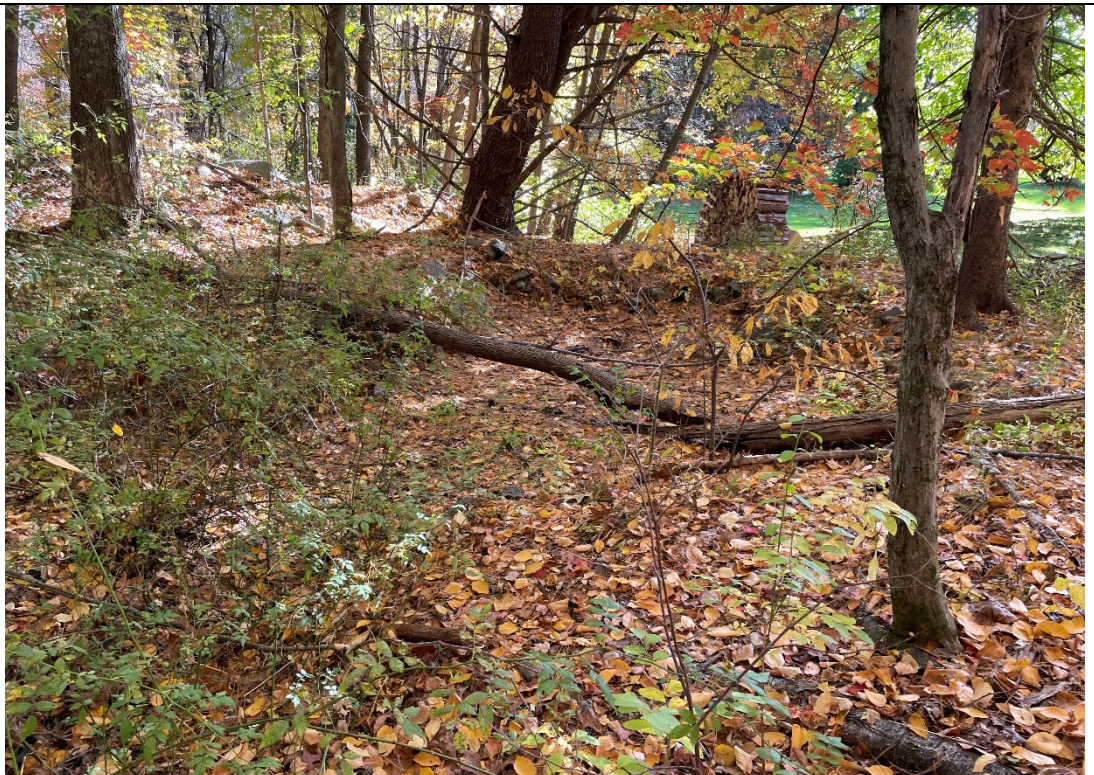
<b>Photo No.</b> 10	<b>Date:</b> 10/18/2022
------------------------	----------------------------

**Direction Photo Taken:**  
Southeast

**Description:**  
View of steep bank along western side of Isolated State Wetland D within the southern portion of the property

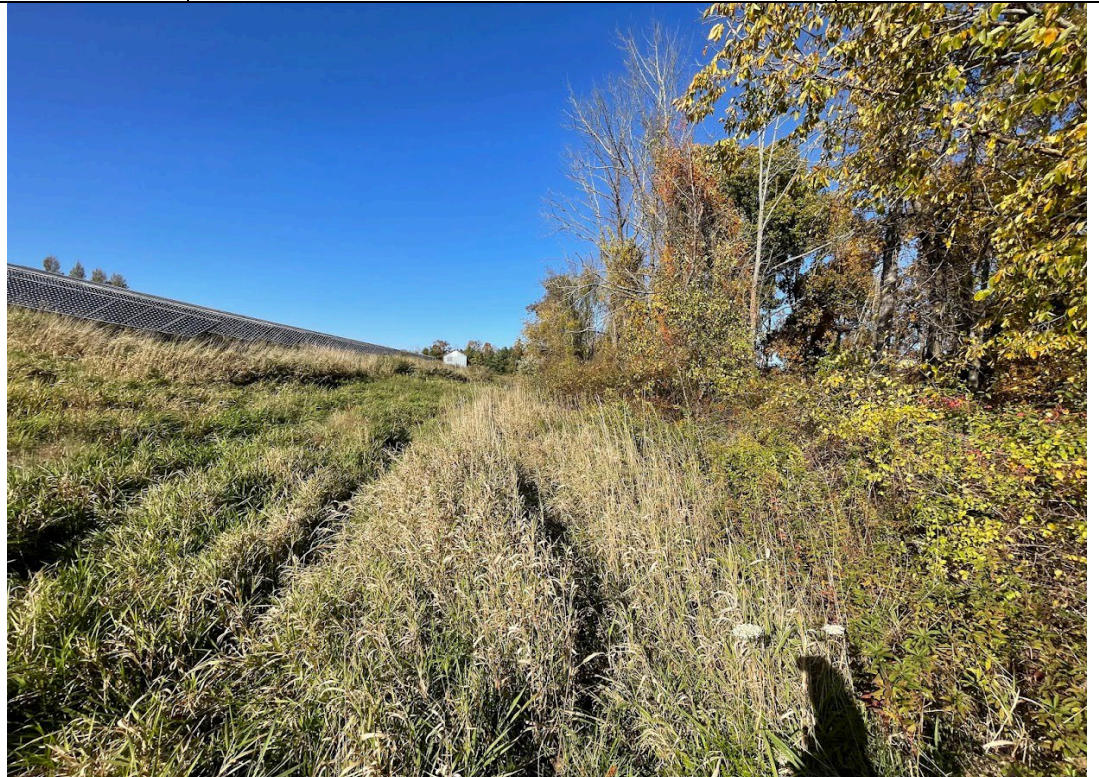
**Direction Photo Taken:**  
North

**Description:**  
Isolated lawn seep (CT-1) located downgradient of the office building and solar field. Hydric soils are dominated by one species of hydrophytic grass.

One emergent seep wetland was observed near the southeast corner of the solar field, at the downgradient extent of a meadow area. This wetland is labeled CT 1 and demarcated by flags WF-1 through WF-4. It occupies approximately 370 SF and is dominated by reed canary grass (*Phalaris arundinacea*). On the day of investigation, soil was mucky at the surface and approximately 0.5-inch of standing water was pooled within a tire rut located within the center of the wetland.

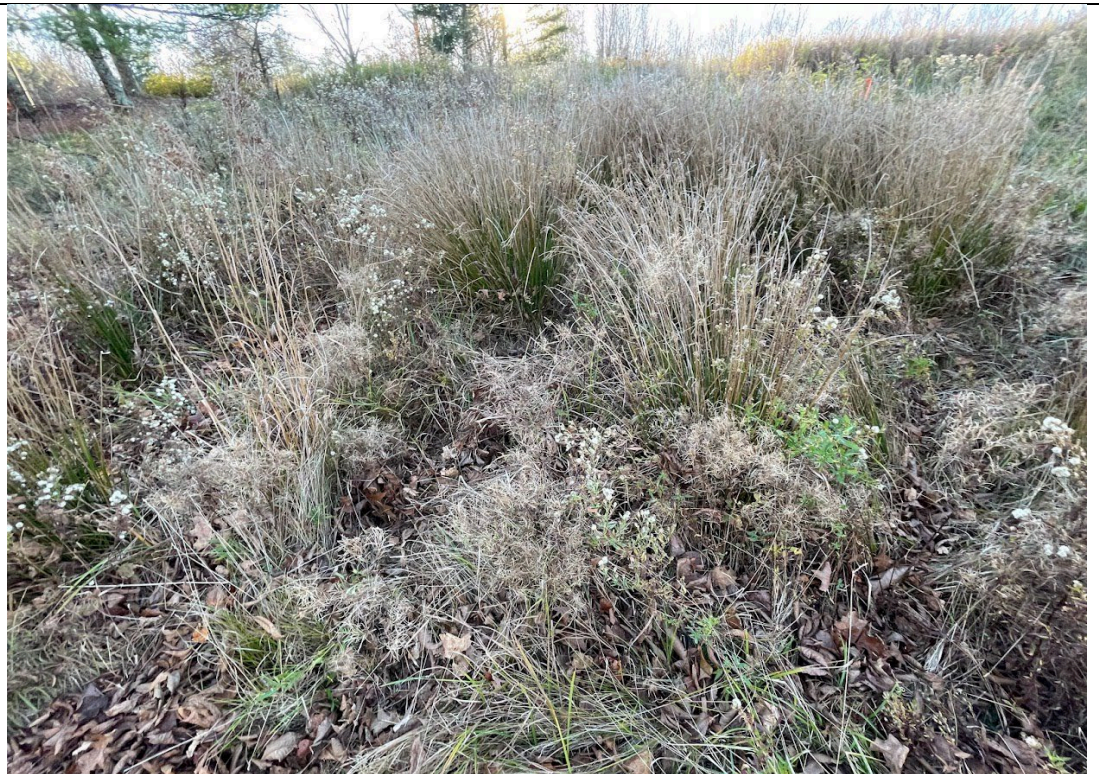
<b>Photo No.</b> 2	<b>Date:</b> 10/18/2022
-----------------------	----------------------------

**Direction Photo Taken:**  
West

**Description:**  
Isolated lawn seep (CT-2) located east of Timex Road and north of the main parking area. Several hydrophytic vegetation species are present.

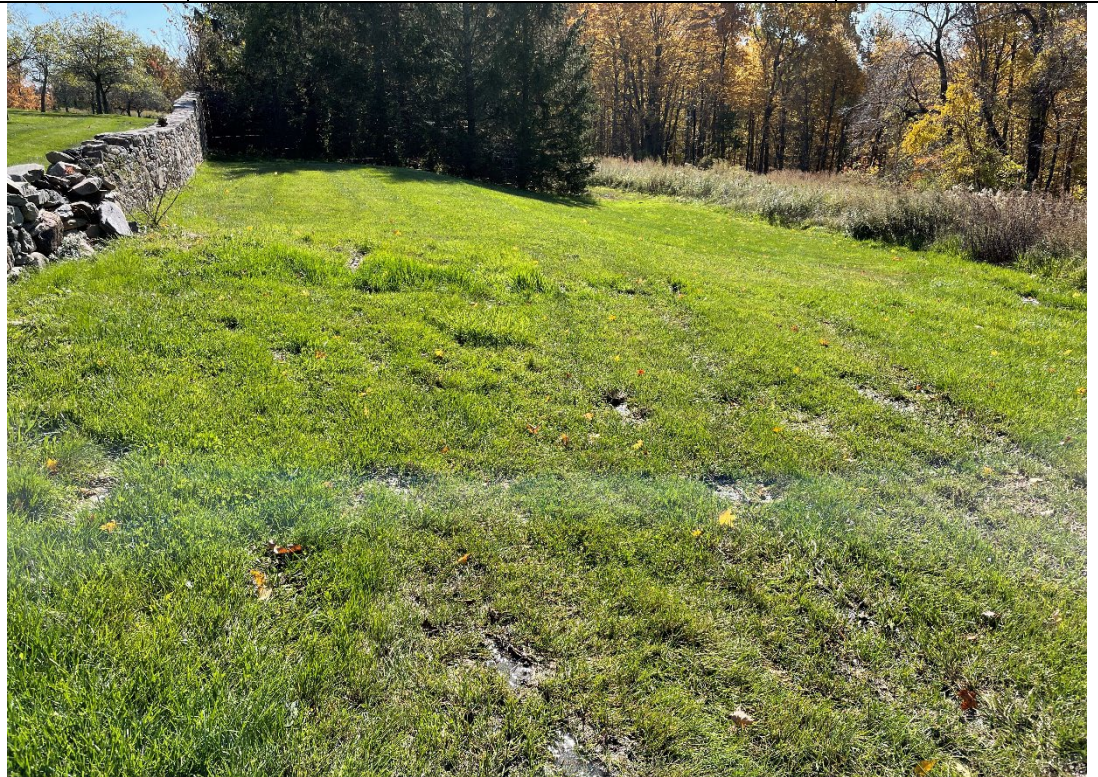
<b>Photo No.</b> 11	<b>Date:</b> 10/18/2022
<b>Direction Photo Taken:</b> South

**Description:**  
Southern of two isolated lawn seep wetland areas to the west of the Timex office building (CT-3). The manicured lawn west of the stone wall was underlain by saturated, hydric soils. See surface water present.

Two small lawn seepage wetland areas, labeled CT 3 and CT 4, exist to the west of the existing Timex building. They measure approximately 2,000 SF and 3,800 SF respectively and are flagged as WY-1 through WY-14 and WX-1 through WX-11. Both wetlands originate at the foundation of retaining walls and decorative stone walls. It appears that the construction of these features compacted the soils and intercepted the groundwater table allowing shallow hydric soil formation. These wetlands have seasonal surface water discharges that infiltrate into the upland till soils located immediately downgradient of the lawn areas. While the northern of the two areas features maintained lawn, the southern area has a combination of maintained lawn and a portion that transitions to an open field with upland herbaceous

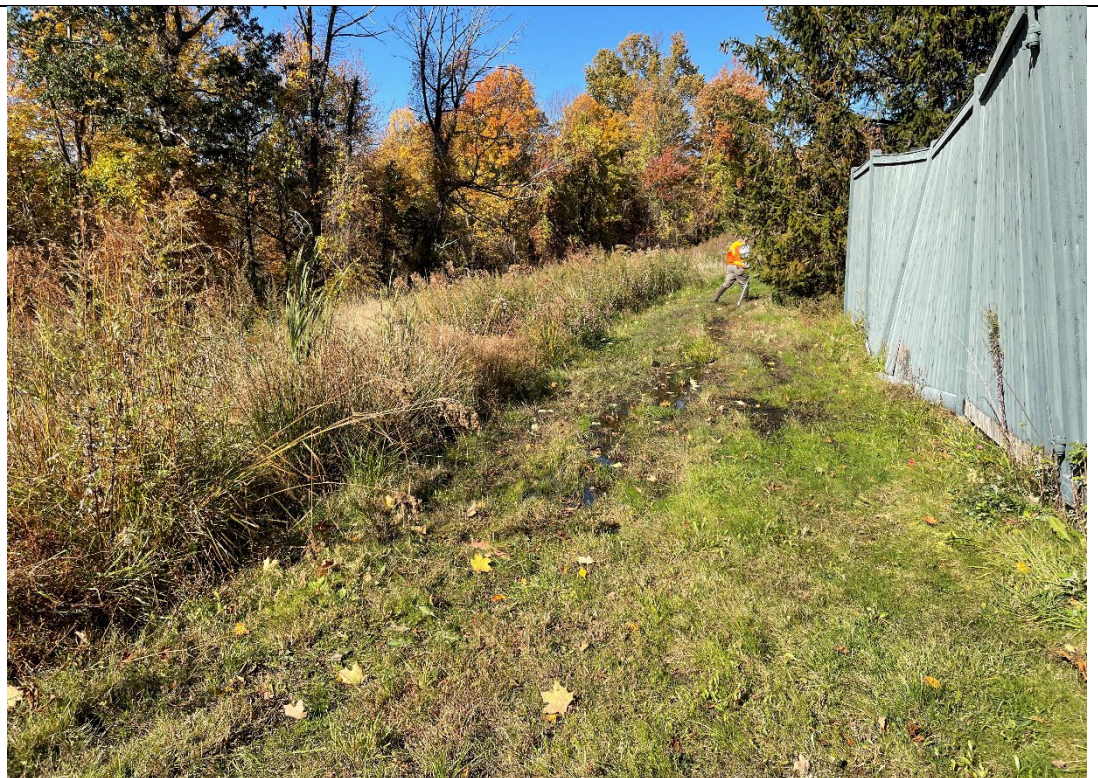
<b>Photo No.</b> 12	<b>Date:</b> 10/18/2022
<b>Direction Photo Taken:</b> North

**Description:**  
The northern of two isolated lawn seep wetland areas to the west of the Timex office building (CT-4). Standing water was observed above hydric soils with some hydric vegetation identified within the herbaceous meadow to the west.
